## Home Inspection Report

**1234 Anywhere Rd.**

**Citywide, STATE 43000**

Inspected on Tue, Jul 30 2013 at 10:00 AM

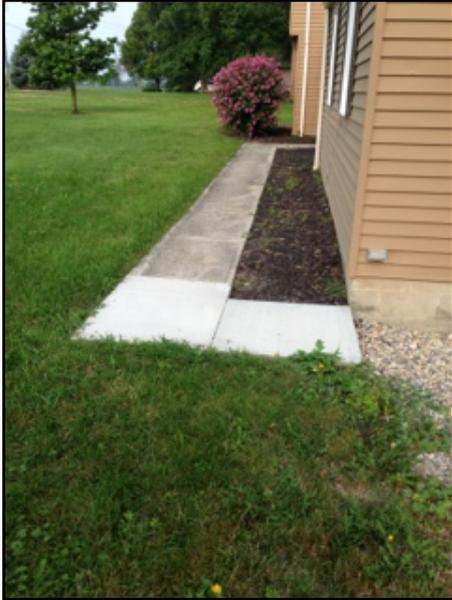
Figure 1-1

Walk to front door.

The front walk in need of crack repairs.

Prior sections of concrete replaced at front walk.

The front concrete porch cracking and settling visible.

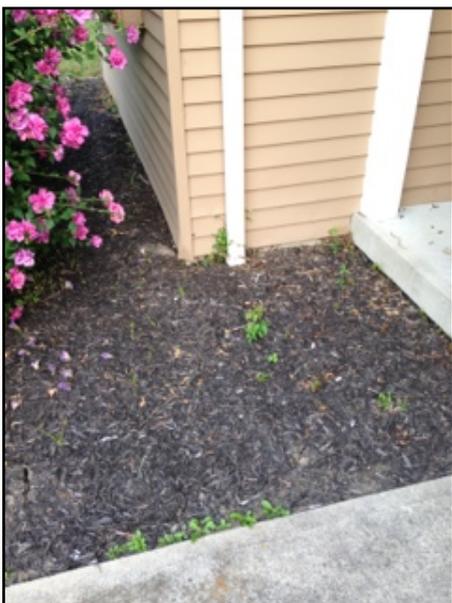
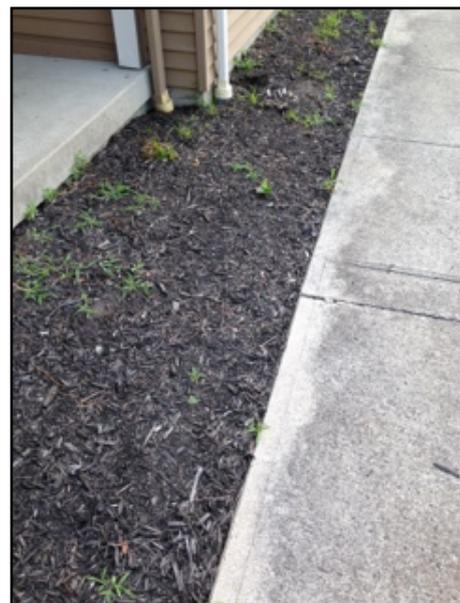
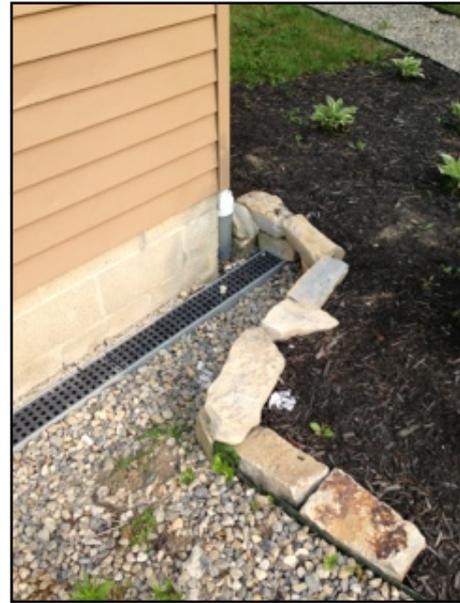
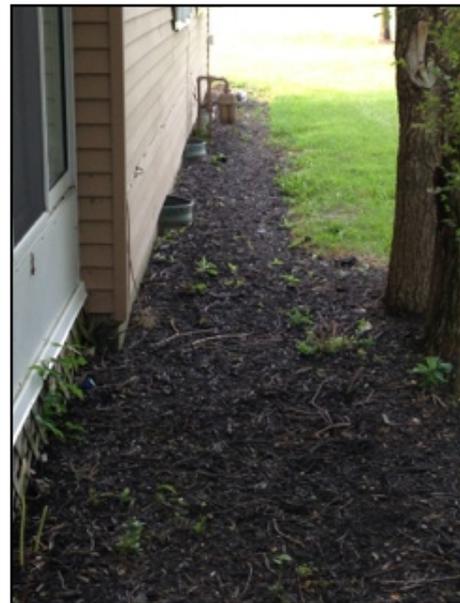
Comment 4:  
Low soil perimeter of structure.  
Underground drainpipes appear added recommend asking current owner where  
this water drains off at.  
Drain off location not found at time of inspection.

Underground drainpipes appear added recommend asking current owner where this water drains off at.

Drain off location not found at time of inspection.

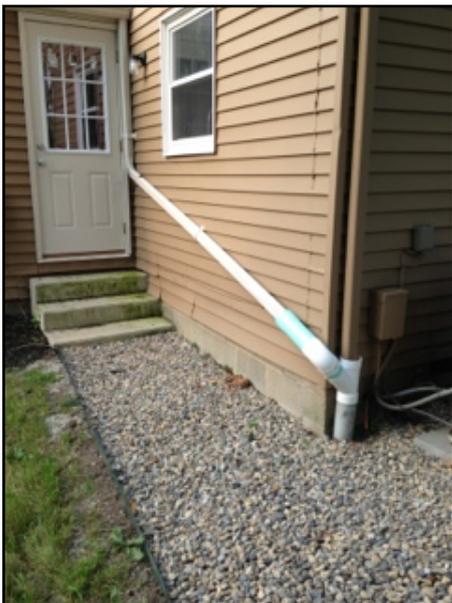
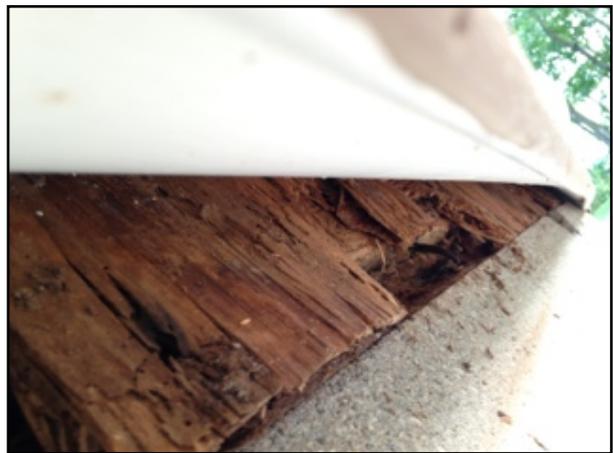
Multiple denting and damage over the years.

Sections of siding have been replaced with vinyl material face fastened to the wall structure.

Vinyl siding loose pieces rear wall of garage and east rear wall of the home, visible underside damaged wood structure.

Possible insect infestations such as ants or termites and visible water moisture rot.

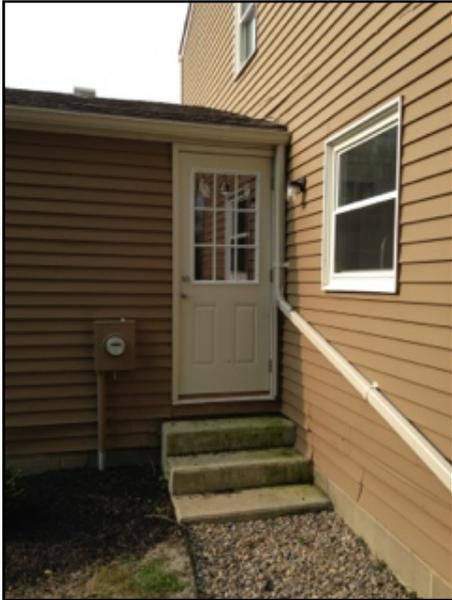
Figure 9-1

Wood threshold below door installed has signs of prior moisture rot. Possible insect activity.

Door will not open and close correctly due to frame being installed incorrect

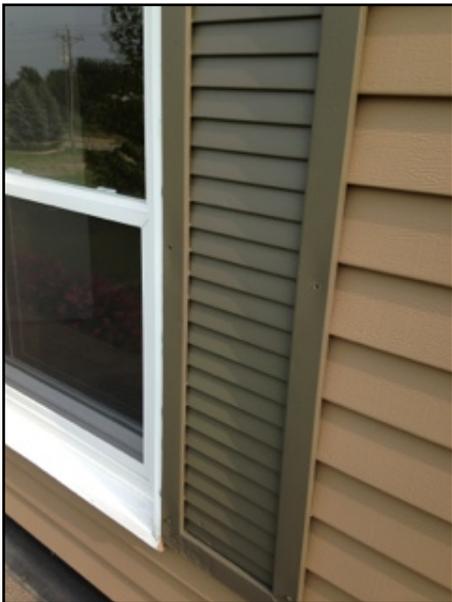
Figure 11-1

Metal shutters dented and damaged, appear original.

7) Metal shutters dented and damaged, appear original.

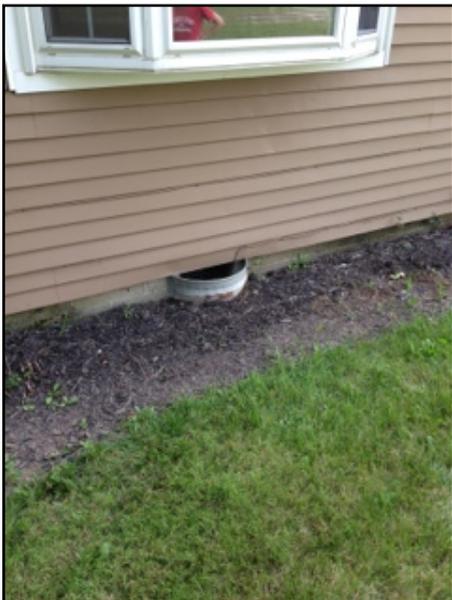
Figure 13-1

Siding compressed below west side bag window. Possible hidden damage.

9) Siding compressed below west side bag window. Possible hidden damage.

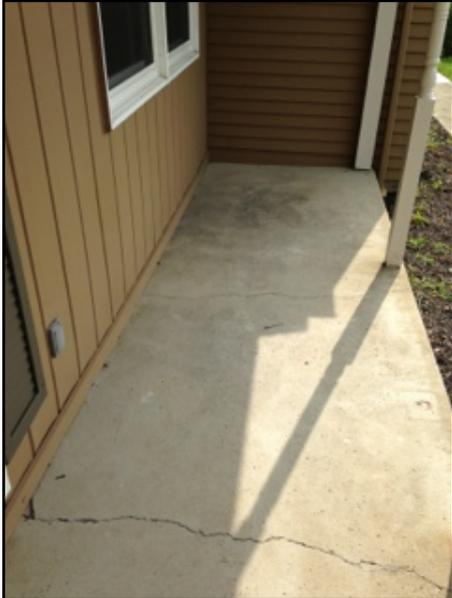
Figure 14-1

Front concrete porch sloped toward structure. Possible hidden damage at front wall of home.

10) Front concrete porch sloped toward structure. Possible hidden damage at front wall of home.

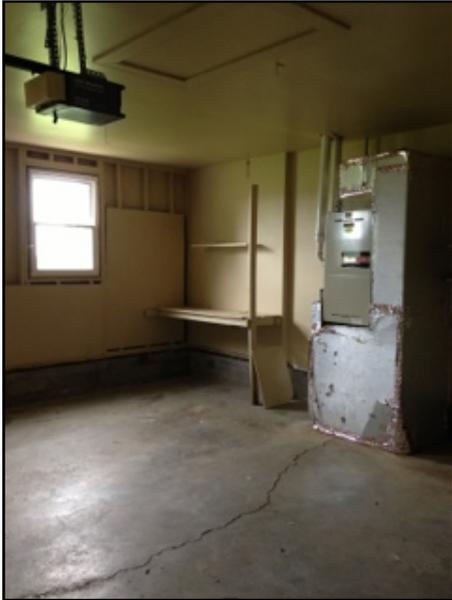
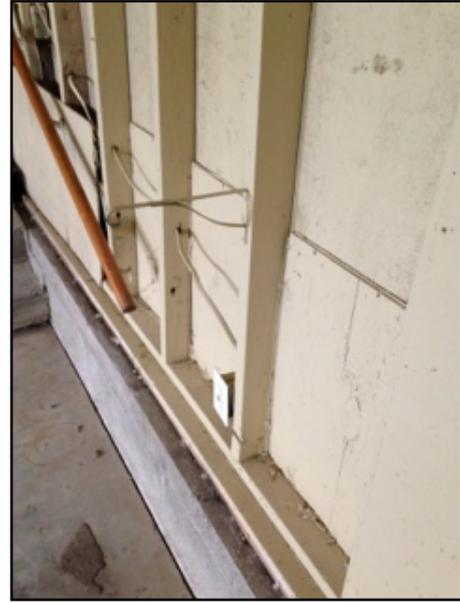
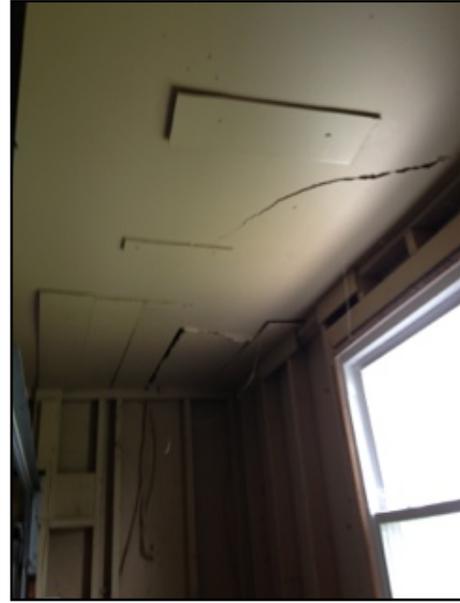
Garage interior. Ceiling drywall sagging and broken pieces.  
Exterior wall damage due to moisture rot and insect activity prior.  
Steps to interior dropped left side.  
Garage floor dropped approx 2"+.  
Multiple cracking at garage walls.

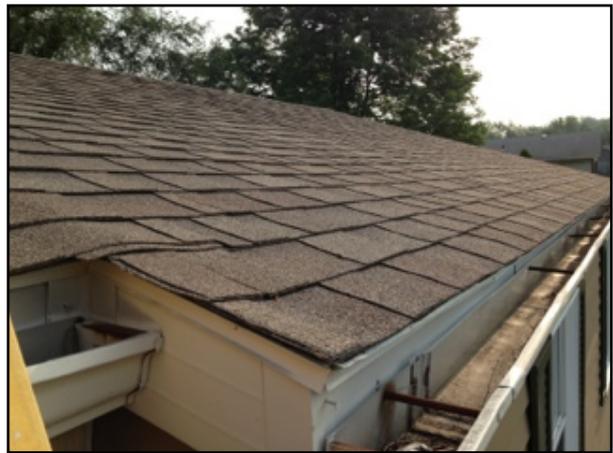
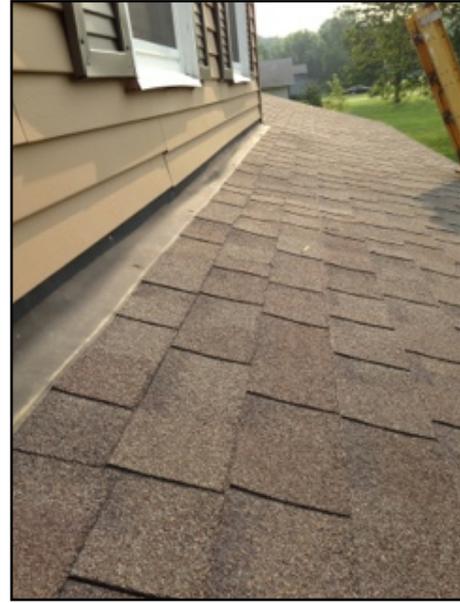
Front porch roof depression in roof sheathing possible prior water damage hidden.

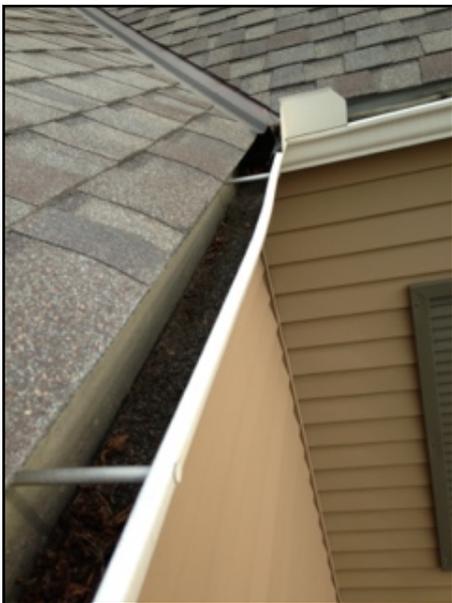
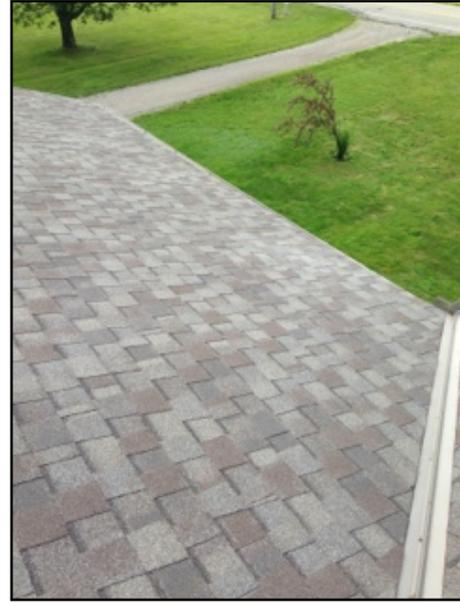
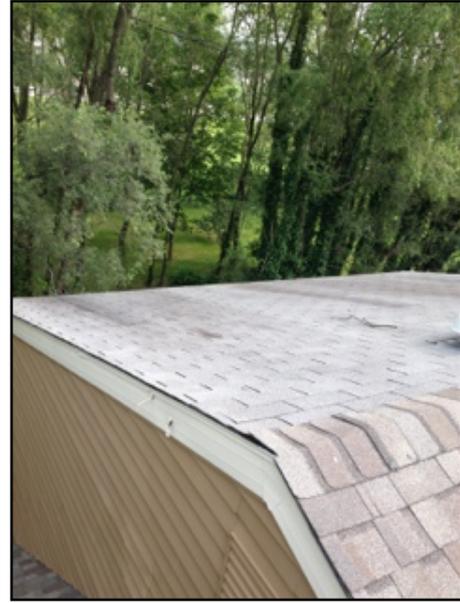
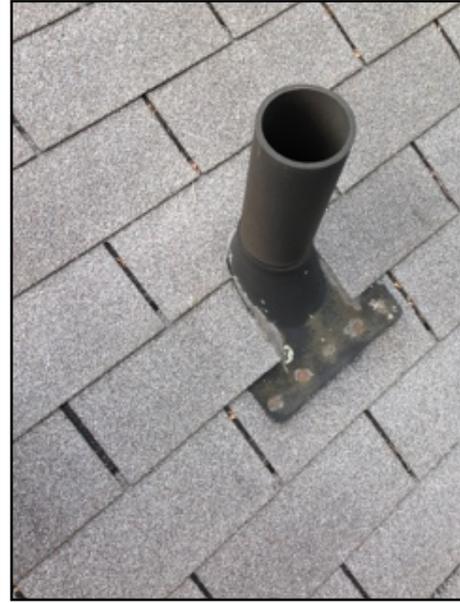
Comment 19:  
Upper main roof rear side not replaced.  
Shingles are older and three tab gray not dimensional.  
Rear section shingles not replaced double layer at this time.

14) Upper main roof rear side not replaced.

Rear section shingles not replaced double layer at this time.

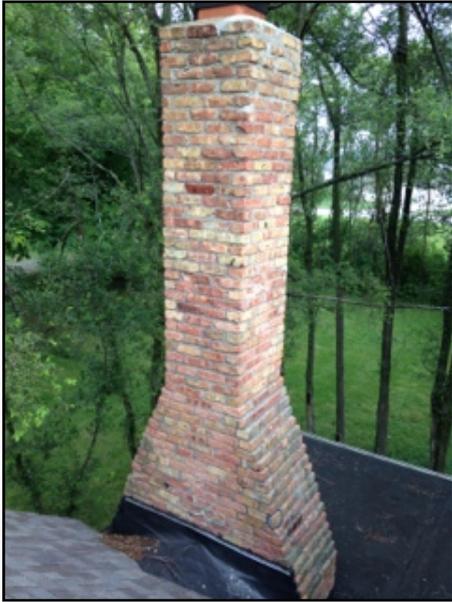
Figure 21-1

**Comment 21:**  
Chimney in need of repairs tuckpointing at brick mortar joints and top Cap repairs.  
Cricket is covered with rubber roof material.

16) Chimney in need of repairs tuckpointing at brick mortar joints and top Cap repairs.

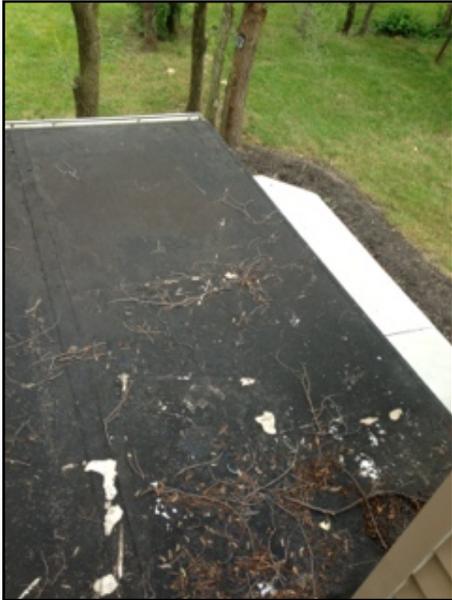
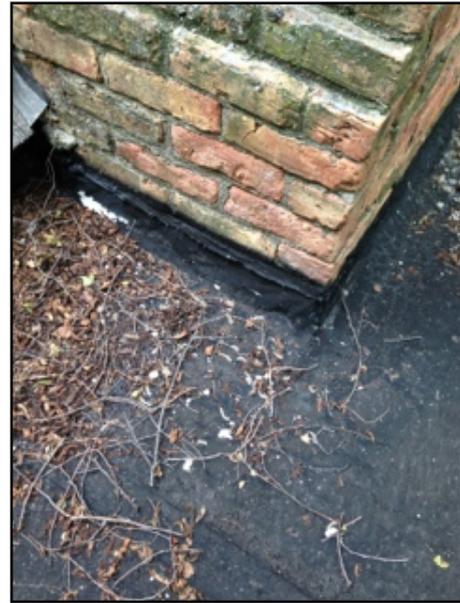
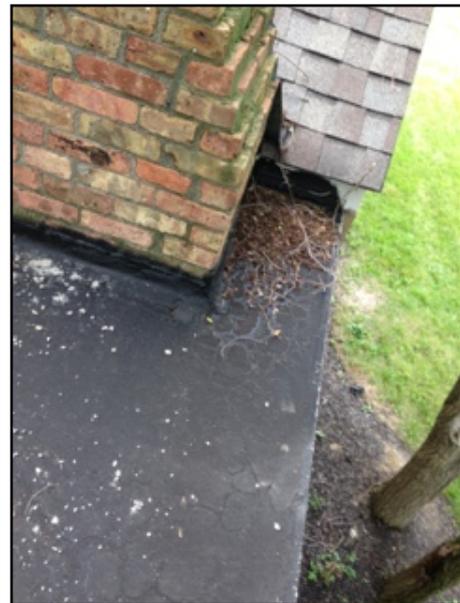
Rubber roof patch material used for flashing between home and flat roof is now in deteriorated state.

Appears large very active bees nest at the west side of chimney where meets wall of structure.

17) Flat roof porch rear of home sealed over with tar roof materials. Rubber roof patch material used for flashing between home and flat roof is now in deteriorated state. Appears large very active bees nest at the west side of chimney where meets wall of structure.

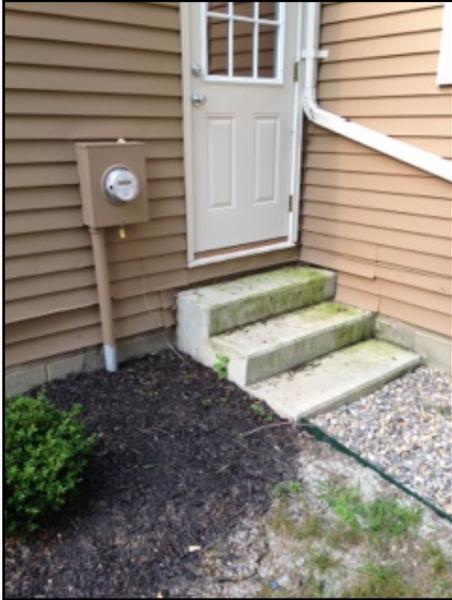
Figure 24-1

Concrete block cracks foundation wall rear side garage where meets home and concrete steps.

19) Concrete block cracks foundation wall rear side garage where meets home and concrete steps.

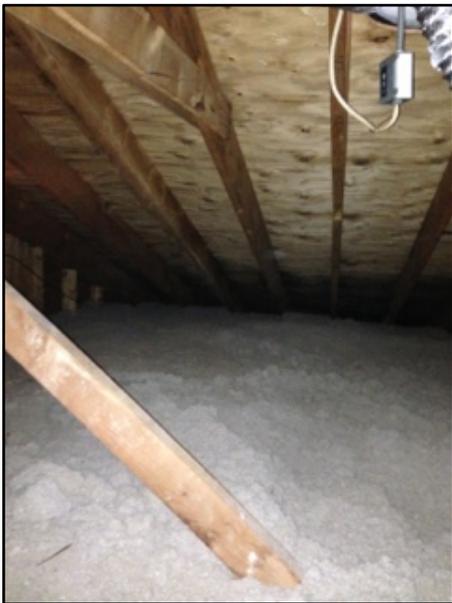
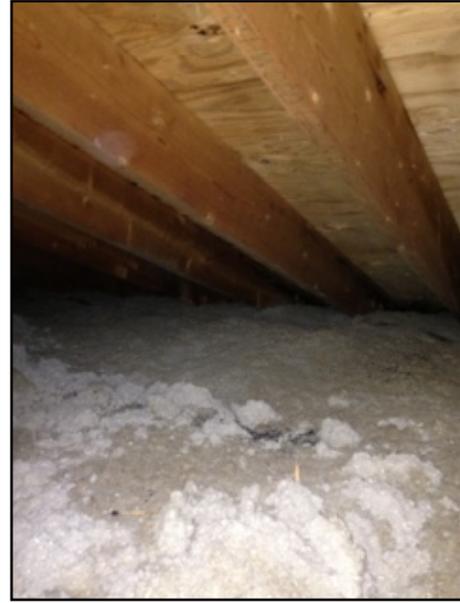
Mold like staining visible at the lower perimeter of the attic.

The staining appears to be caused by lack of soffit venting.

There are special design vents available for installation to solve this problem.

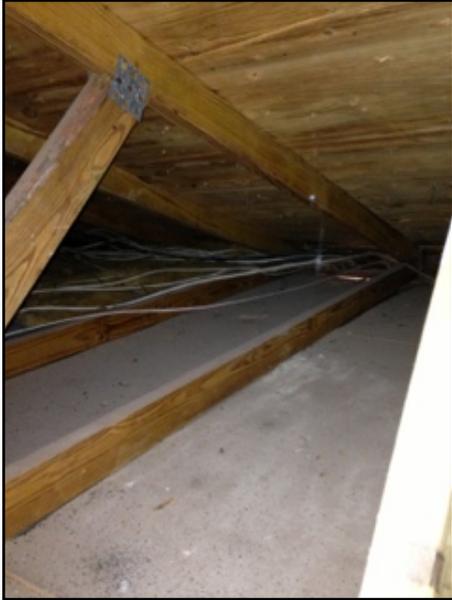
Figure 26-1

Appears possible water into structure if gutters clog.

The water migration is possible into power panel below and visible damage to the drywall ceiling.

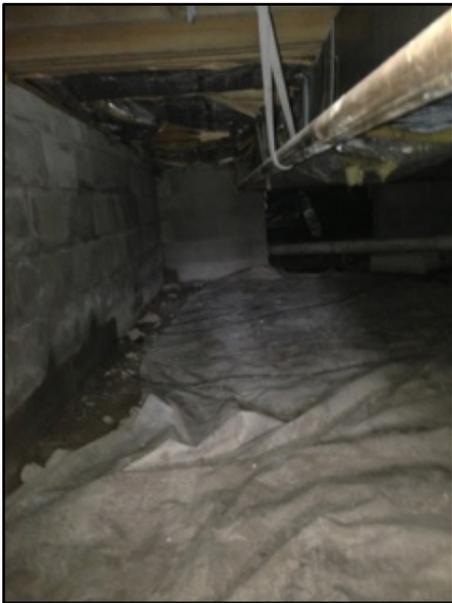
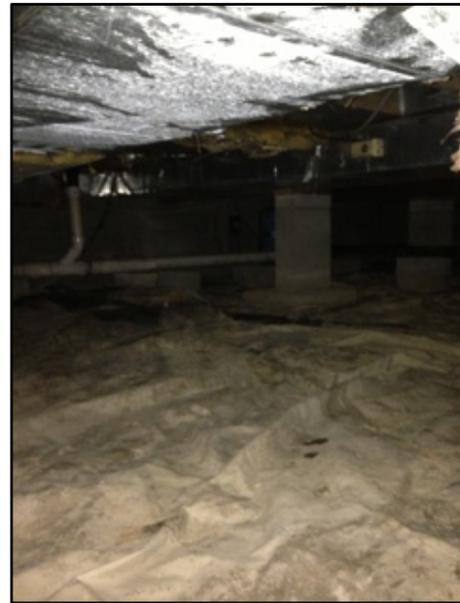
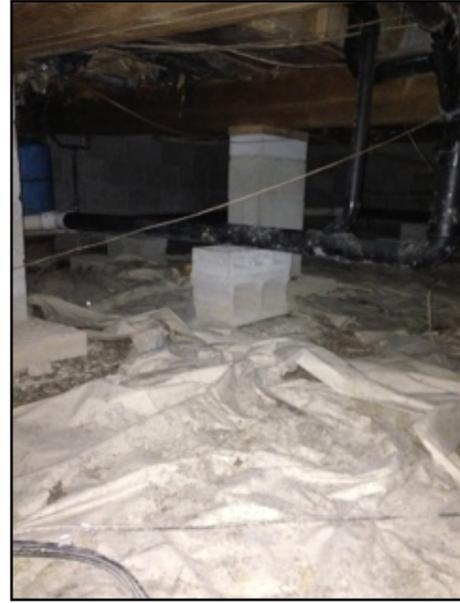
East Crawl space photos.

Rear wall of crawl has multiple cracks filled with caulking. Appears wall pushed inward. Further evaluation recommended.

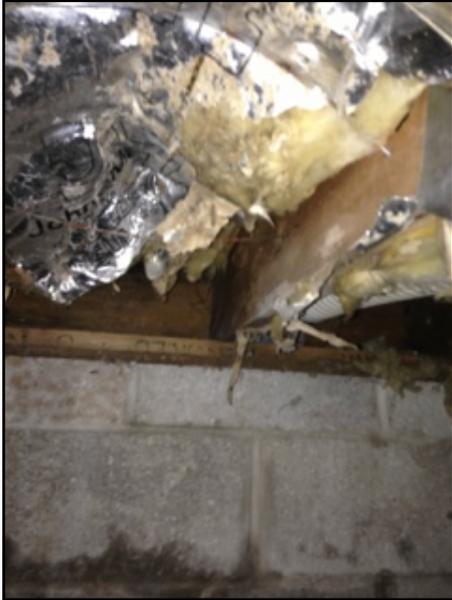
Figure 29-1

Under floor insulation damaged in need of repair.

No insulation on ducts also.

23) Under floor insulation damaged in need of repair.

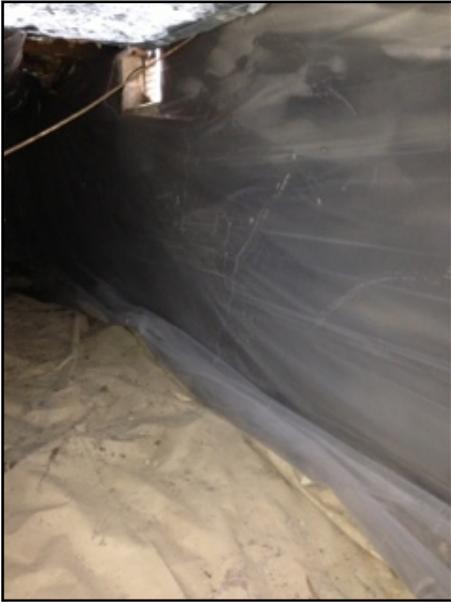
Figure 30-1

West crawl wall lined with plastic sheet appears recent. Possible hidden damage.

24) West crawl wall lined with plastic sheet appears recent. Possible hidden damage.

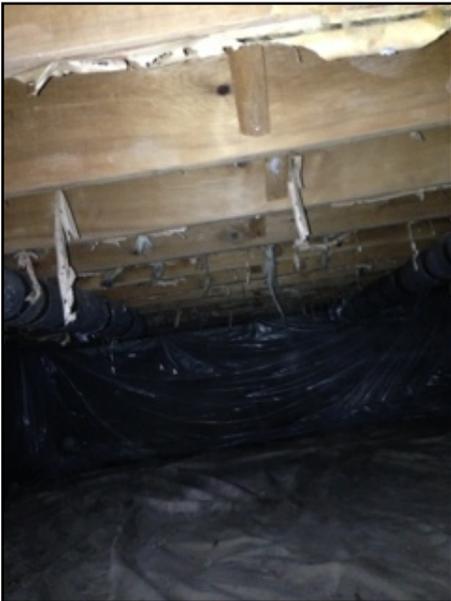
Figure 31-1

Insulation majority has been removed and not replaced.  
Insulating under the floors of home in need.

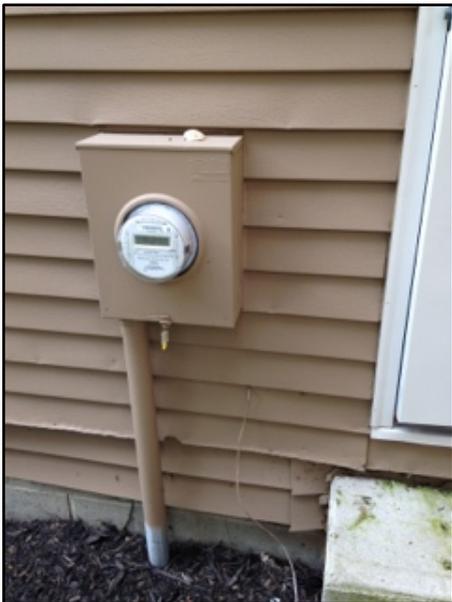
Figure 32-1

**Comment 32:**  
Exterior meter box and interior panel.  
Visible rust at breaker faces.

Visible rust at breaker faces.

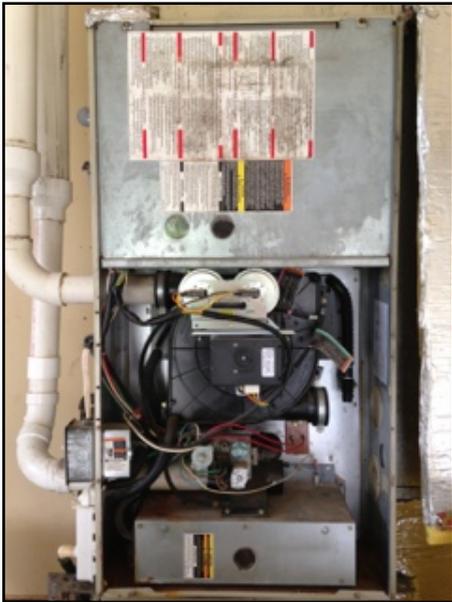
Figure 35-1

Comment 35:  
Furnace photos.

Possible condensate leaks at rubber drain tubing in furnace.  
Recommended servicing unit for efficiency and cleaning.

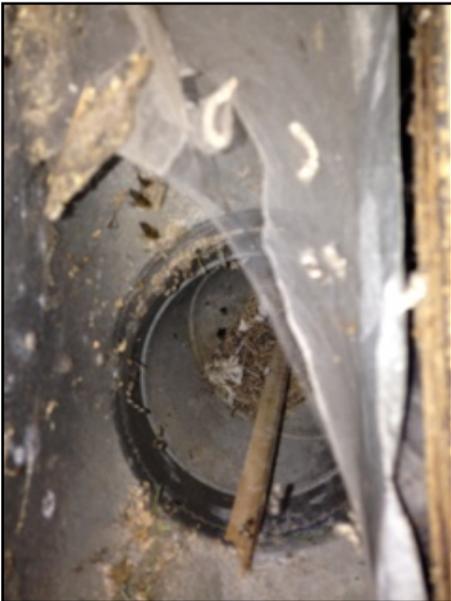
Figure 36-1

Due to finding dust and debris at the floor diffusers and furnace plenum where visible it is recommended to have ducts cleaned and sanitized at this time.

Duct cleaning is recommended to be completed by a certified professional every few years depending on use.

29) Duct cleaning is recommended to be completed by a certified professional every few years depending on use.

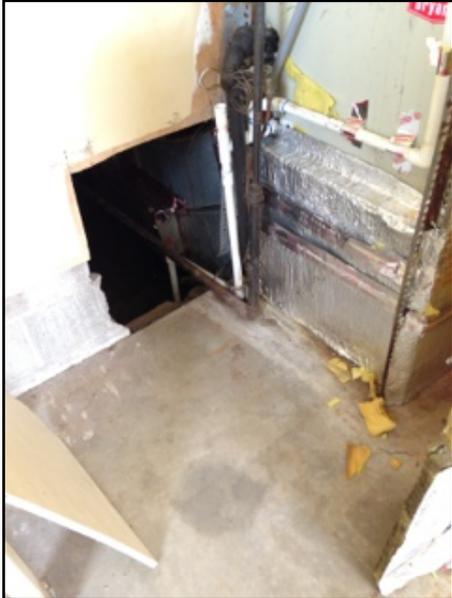
Figure 37-1

Duct and plenum not insulated. All seams of ducts leaking air into crawl below. Rodent feces visible in crawl.

30) Duct and plenum not insulated. All seams of ducts leaking air into crawl below. Rodent feces visible in crawl.

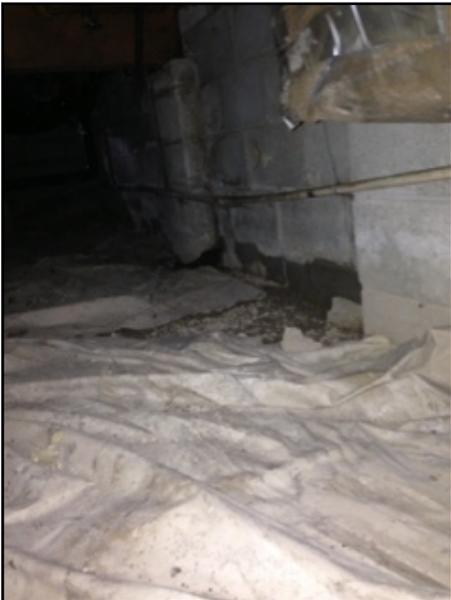
Figure 40-1

Condensate pipe is fastened to interior foundation block wall. Pipe has incorrect slope with sags in pipe. Will slow water flow with higher chance of clog.

32) Condensate pipe is fastened to interior foundation block wall. Pipe has incorrect slope with sags in pipe. Will slow water flow with higher chance of clog.

Air conditioners over 10 years old and heat pumps over 5 years old should be checked, cleaned and serviced yearly by a licensed contractor.

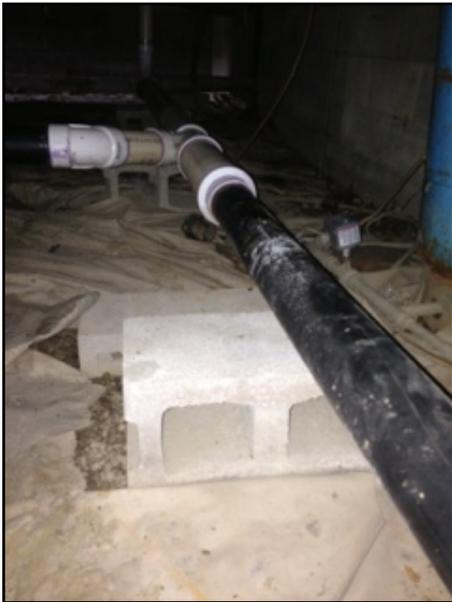
Figure 43-1

The crawl space in need of total cleaning and sanitizing prior to replacement with new vapor barrier due to sewage leaking throughout.

This is considered a major health hazard at this time.

Water when raining appears to flood crawl also

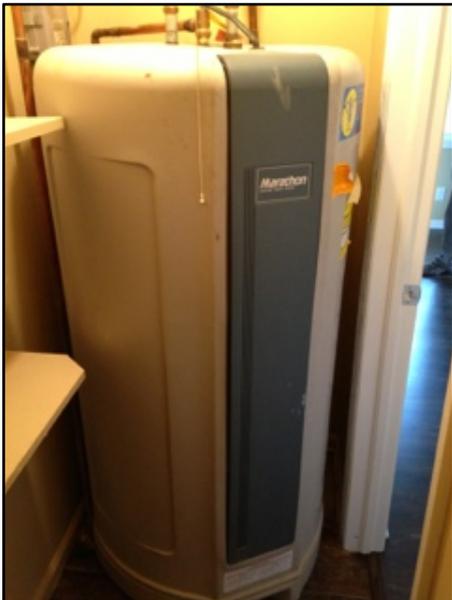
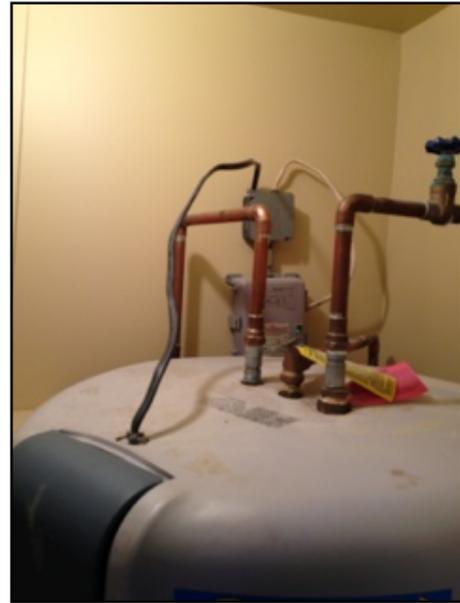
Power feed wires not in conduit.

Elements appear to have been replaced prior years.

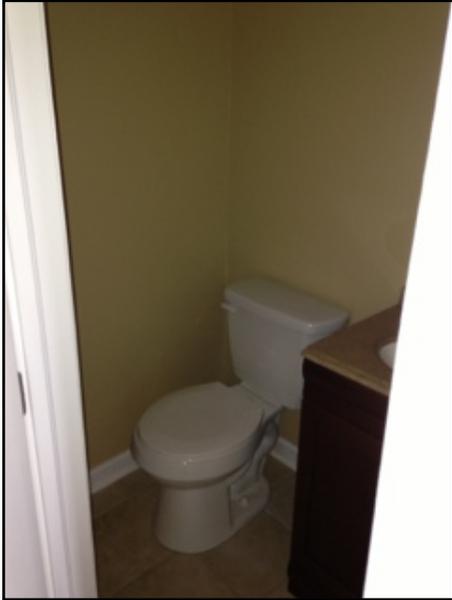
Figure 46-1

Comment 46:  
Bathroom photos.  
Toilet loose at floor.

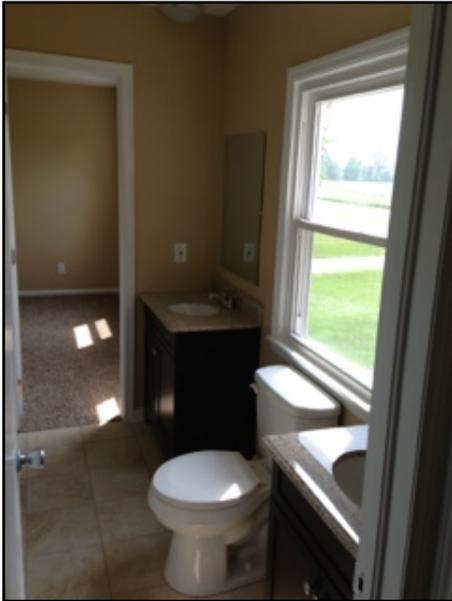
Figure 47-1

Tile in bath may need sealed at joints.

The bath spigot when guest turned on blew out black dirt/ rust in pipe. Possible iron pipe fitting between the feed copper pipe and spigot. Recommend further evaluation.

The bath spigot when guest turned on blew out black dirt/ rust in pipe.

Recommend further evaluation.

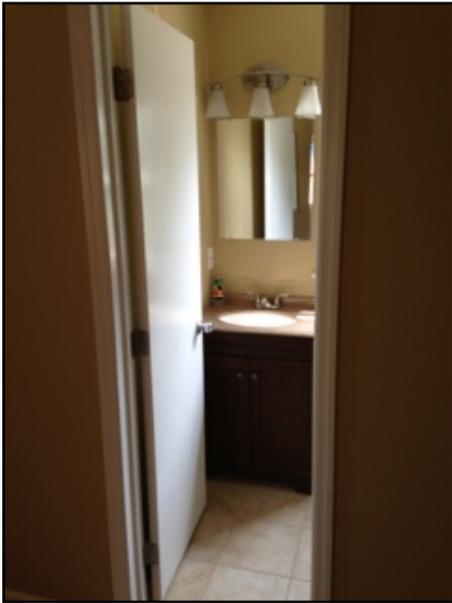
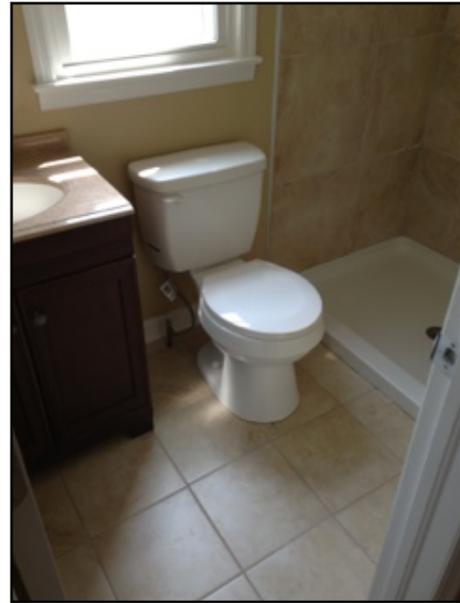
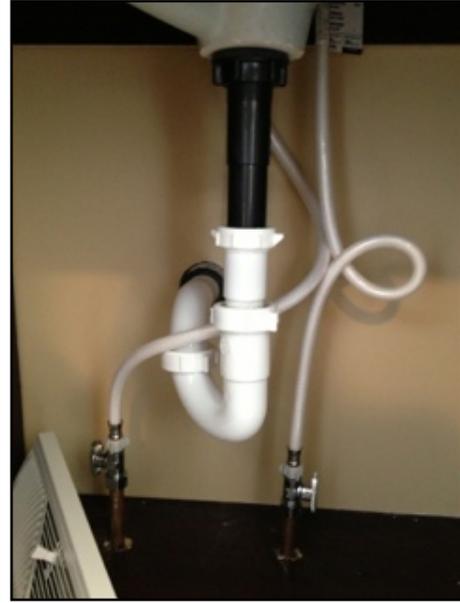
Grout joints cracked at inside corner in shower. Recommend monitor and seal with caulk.

Recommend seal around cover plate of faucet.

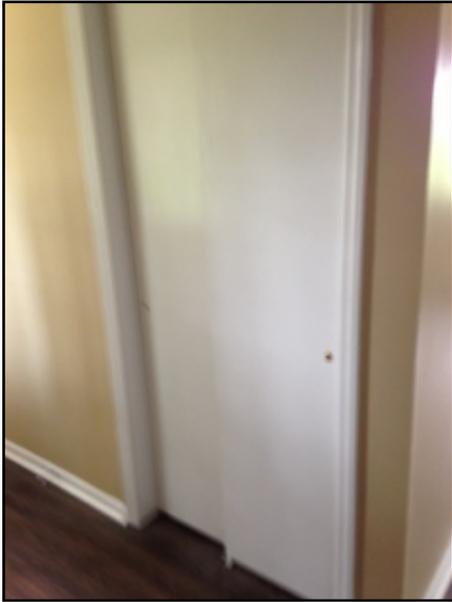
Figure 53-1

**Comment 53:**  
Sliding doors pantry in need of adjustment and missing brass pull tab.

39) Sliding doors pantry in need of adjustment and missing brass pull tab.

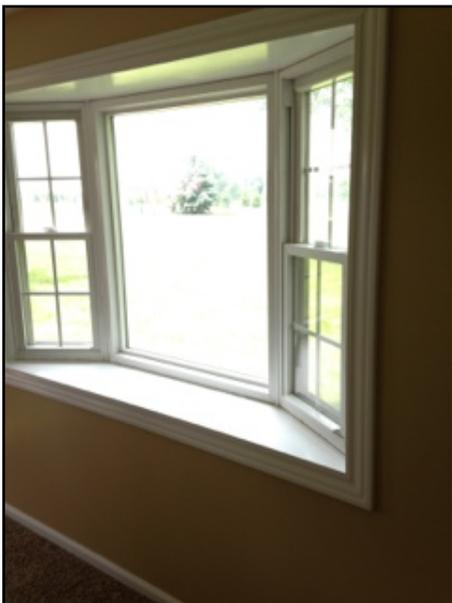
Figure 54-1

**Comment 54:**  
Interior frame bay window moisture stains visible.  
The lower edge of window is not sealed possible due to possible settling of structure below.

40) Interior frame bay window moisture stains visible.

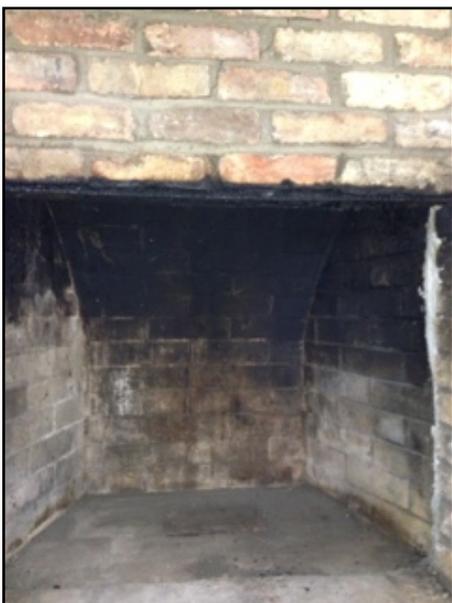
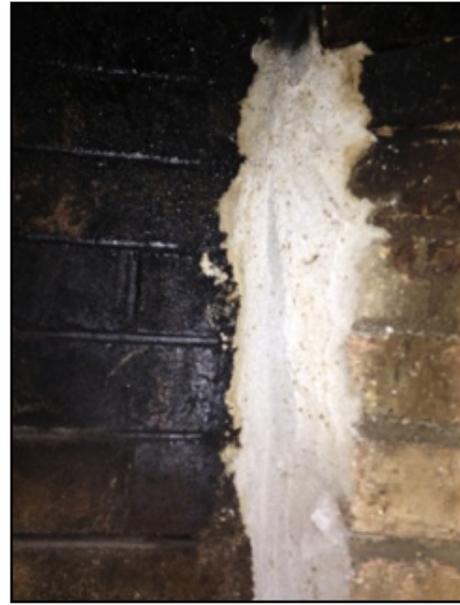
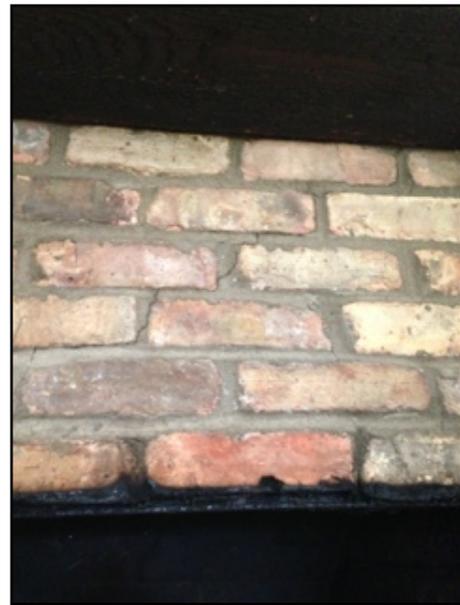
- Fireplace wood burning.
- No screen or doors.
- Damper plate missing.
- Heavy creosote buildup in flue.

Mortar between firebox and front face brick over prior creosote buildup. May need removed and then repairs made prior to new mortar being installed.

41) Fireplace wood burning.

Damper plate missing.

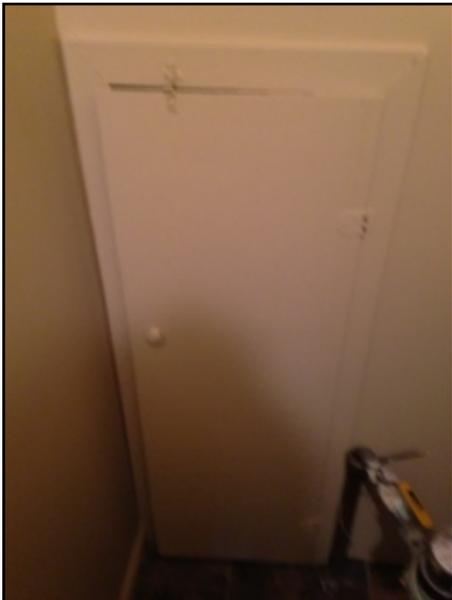
Figure 56-1

Storage area under the steps to upper floor accessible in water heater closet.  
Rodent feces throughout.  
Hole to crawl and hole in wall to upper floor.  
Smell of feces and urine in need of repairs and sanitizing.

Considered a health hazard at this time.

Smell of feces and urine in need of repairs and sanitizing.
