## Home Inspection Report

**1234 Anywhere Rd.**

**Citywide, STATE 43000**

Inspected on Tue, Jul 30 2013 at 10:00 AM

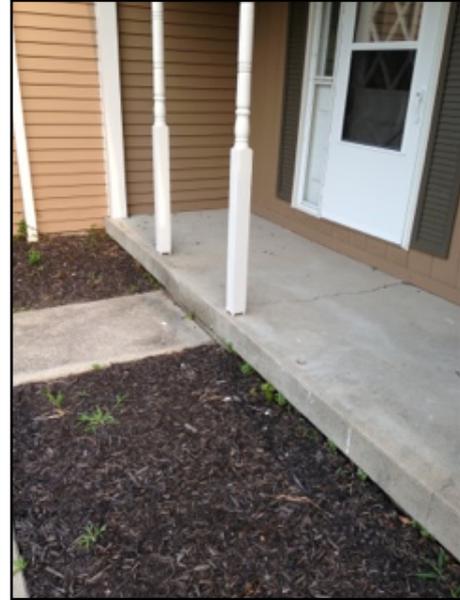
Figure 1-2

The front walk in need of crack repairs.

Prior sections of concrete replaced at front walk.

The front concrete porch cracking and settling visible.

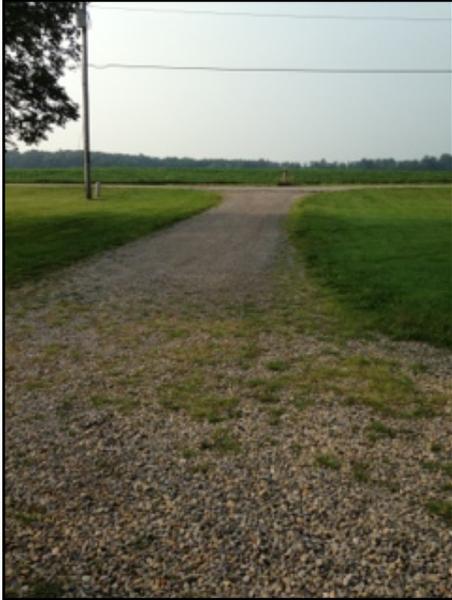
Figure 2-1

Driveway slopes down to home drainage at front of garage does not appear functional until water in gravel is above the drain cover.

Where does this drain off at?

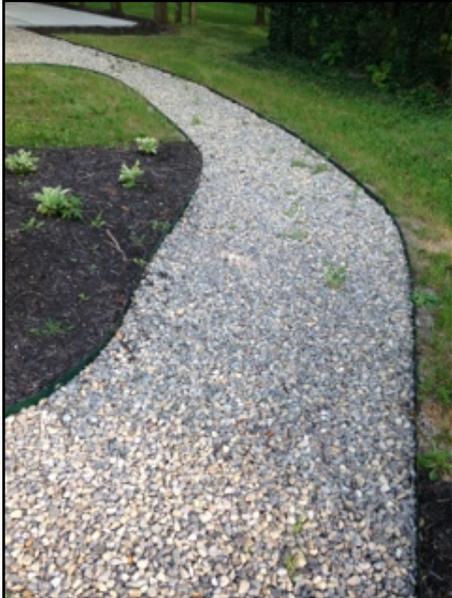
Figure 3-1

Comment 3:  
Rear yard walks and patio .  
Gravel with steel edging

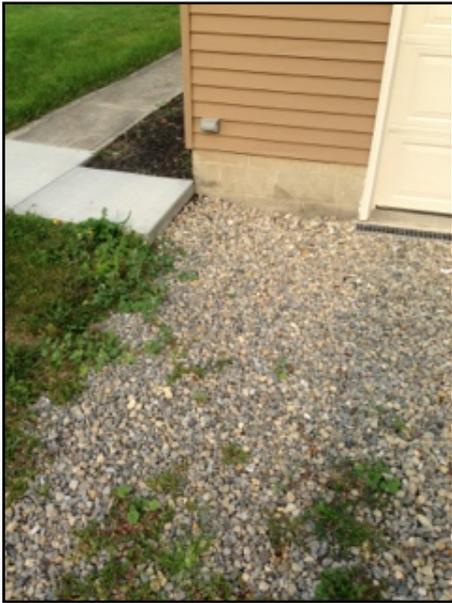
Figure 4-3

Comment 4:  
Low soil perimeter of structure.  
Underground drainpipes appear added recommend asking current owner where  
this water drains off at.  
Drain off location not found at time of inspection.

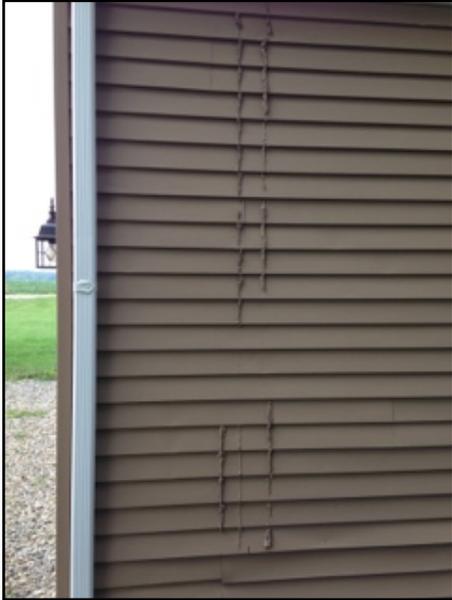
Figure 6-1

Rear of home appears to have had prior exterior structure removed caulking and denting of siding visible at perimeters.

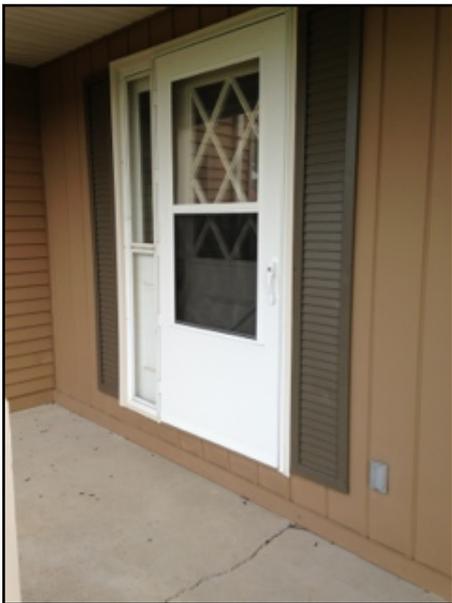
Figure 8-1

Front entrance door frame appears out of level and pushed forward causing siding below to not be plumb.

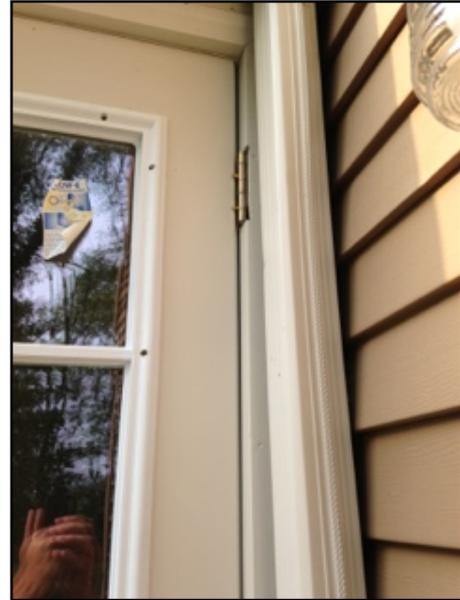
Wood threshold below door installed has signs of prior moisture rot. Possible insect activity.

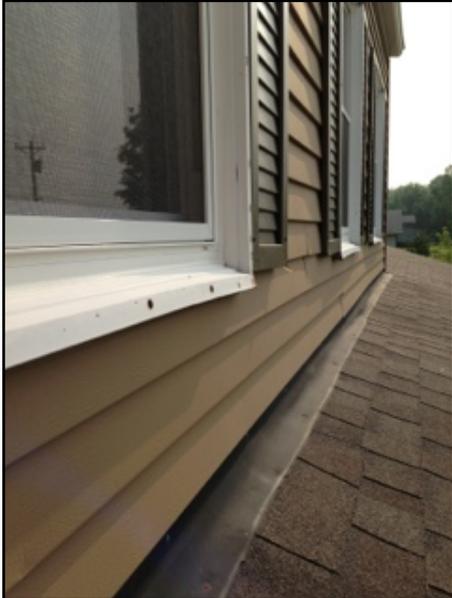
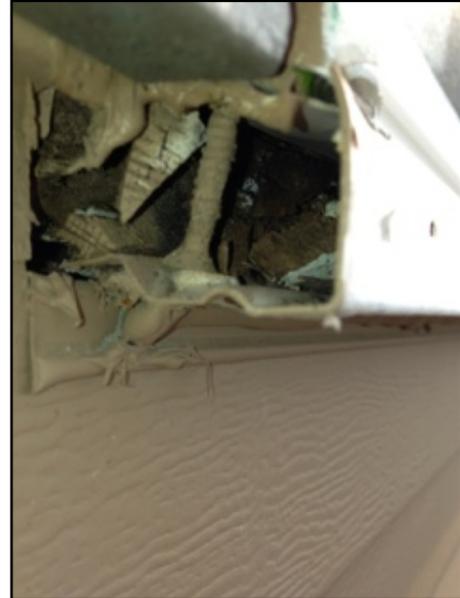
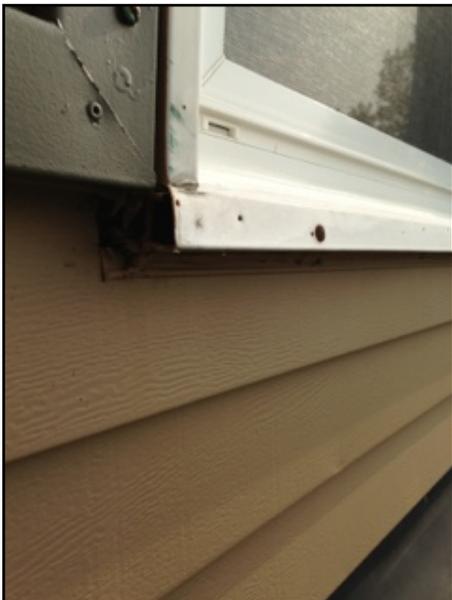
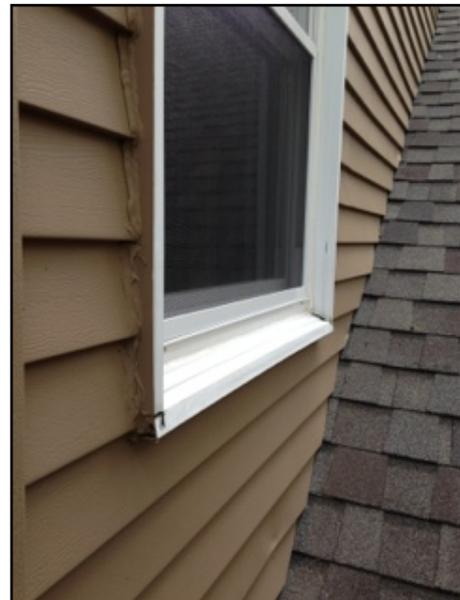
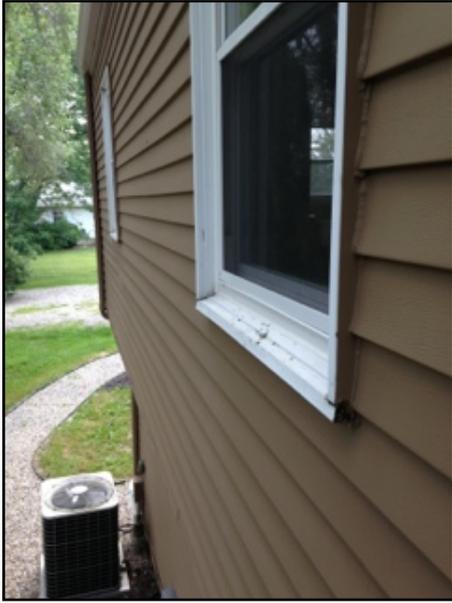
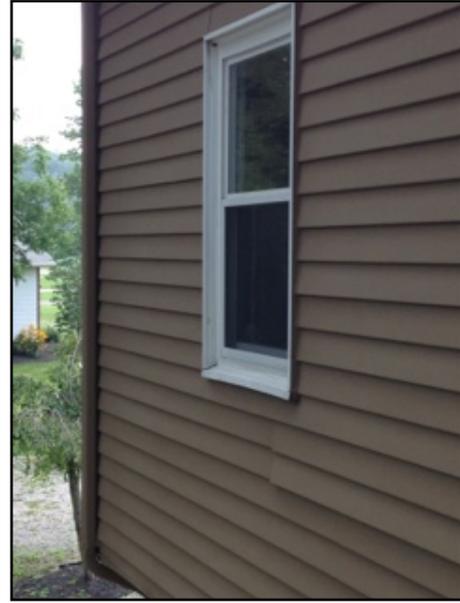
Vinyl window frames sagging and visible rotted wood interior portion of vinyl frames.

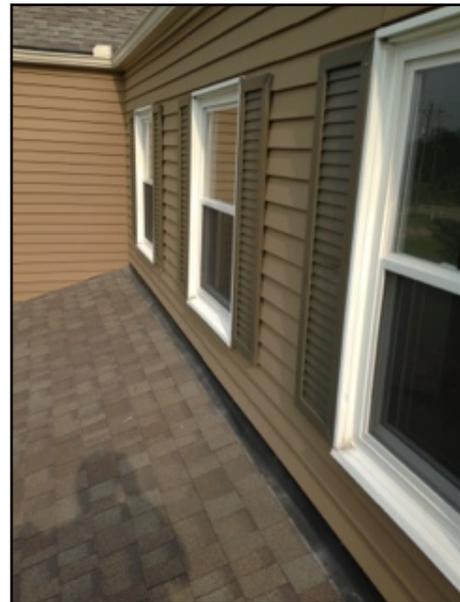
Figure 11-2

Metal shutters dented and damaged, appear original.

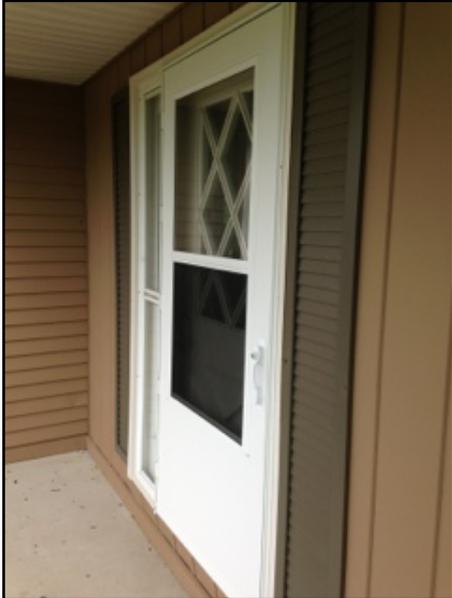
Figure 12-1

Front entrance storm door handle hardware opposite of hardware on entrance door.

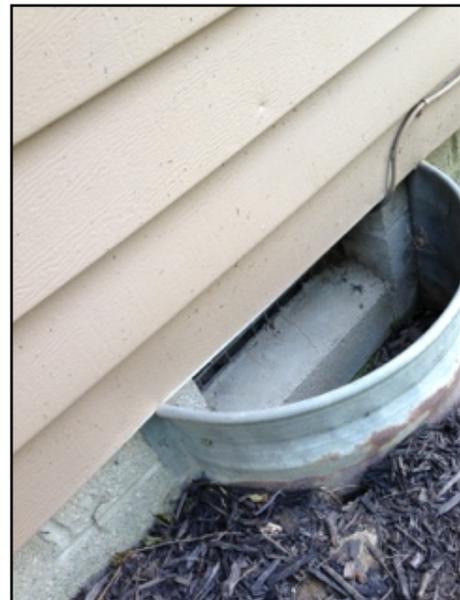
Figure 13-2

Siding compressed below west side bag window. Possible hidden damage.

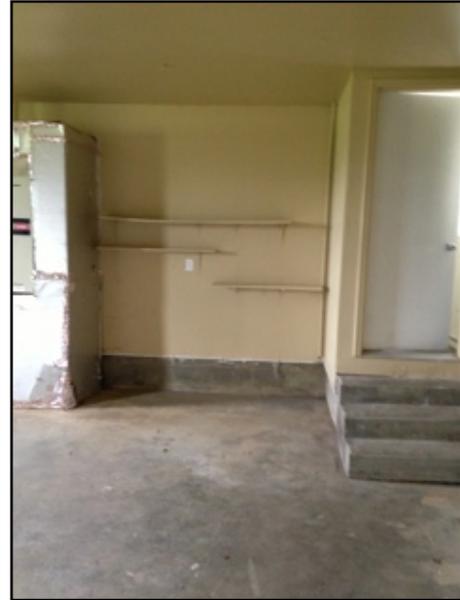
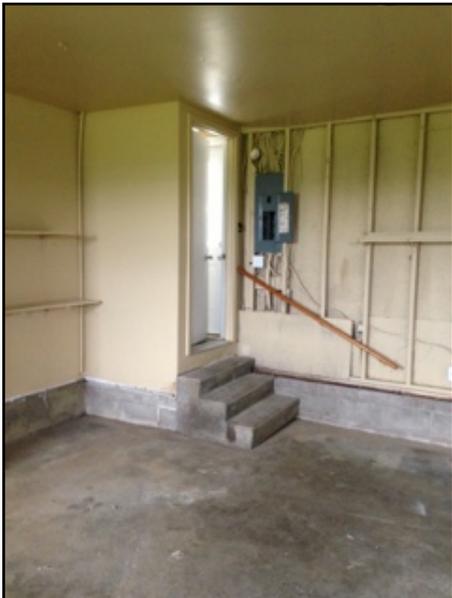
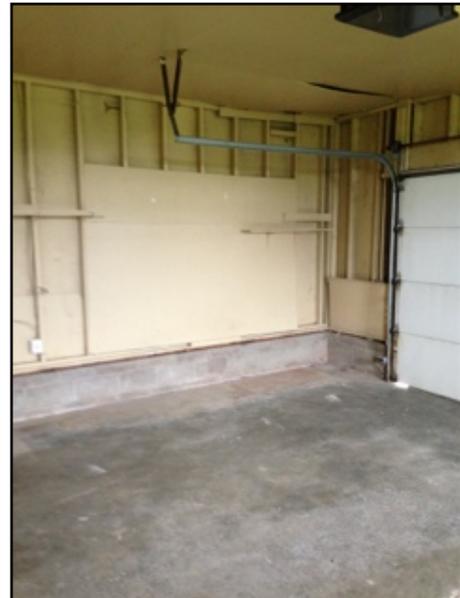
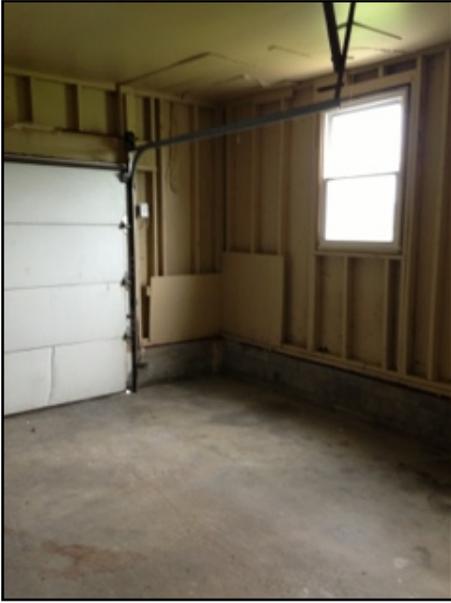
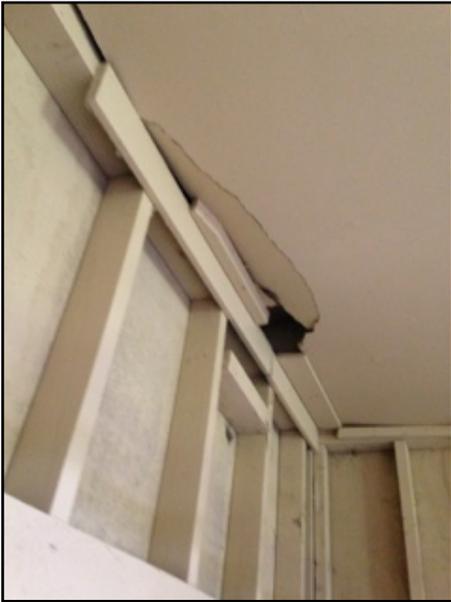
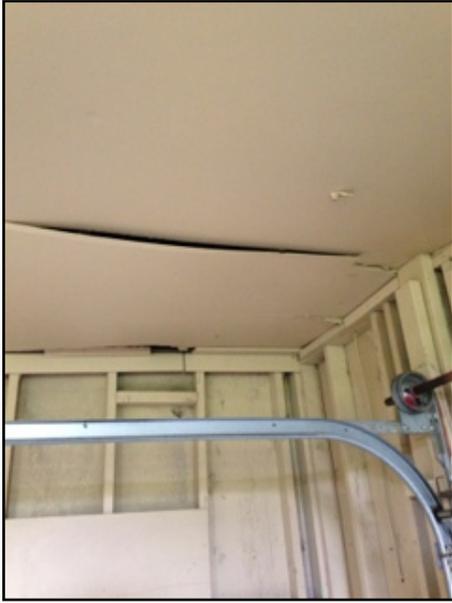
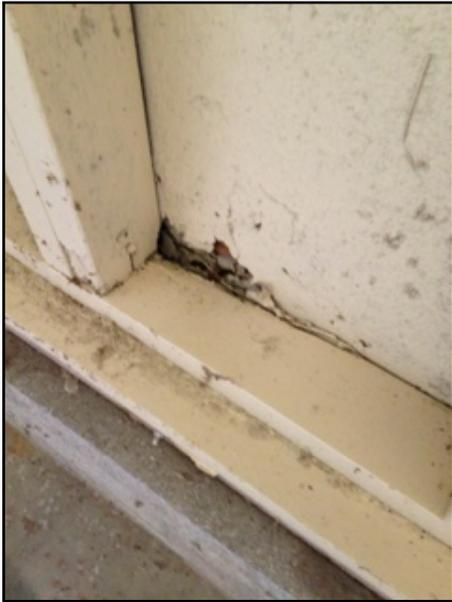
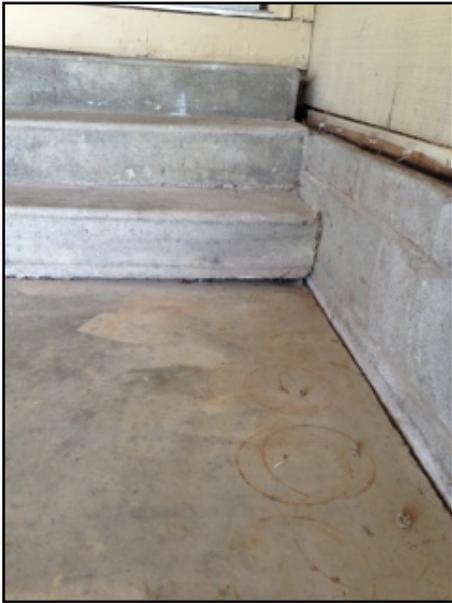
Garage interior. Ceiling drywall sagging and broken pieces.  
Exterior wall damage due to moisture rot and insect activity prior.  
Steps to interior dropped left side.  
Garage floor dropped approx 2"+.  
Multiple cracking at garage walls.

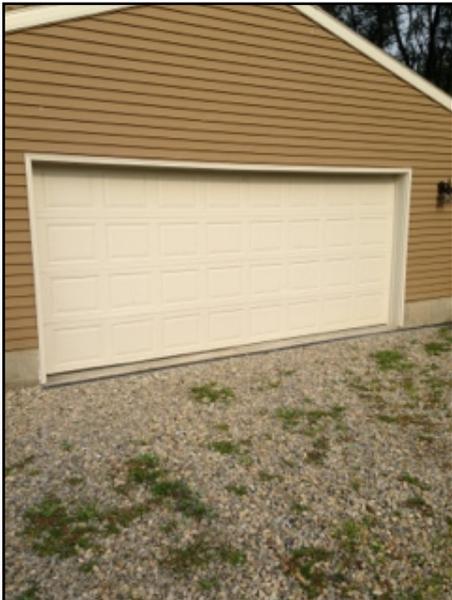
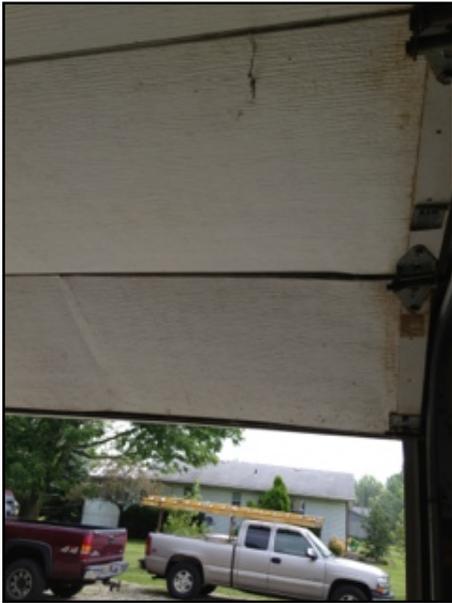
Comment 16:  
Garage door dented visible exterior.  
Door recently painted.

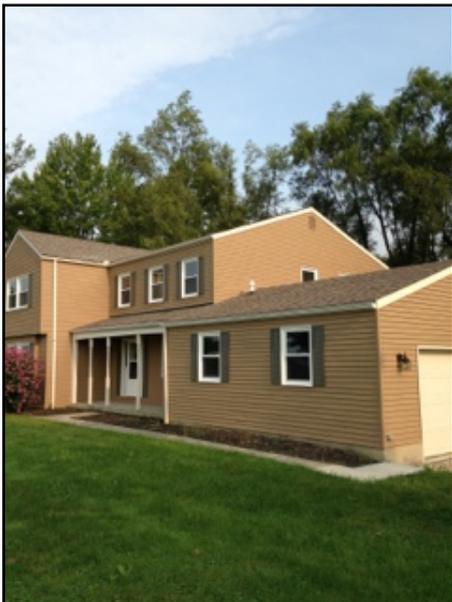
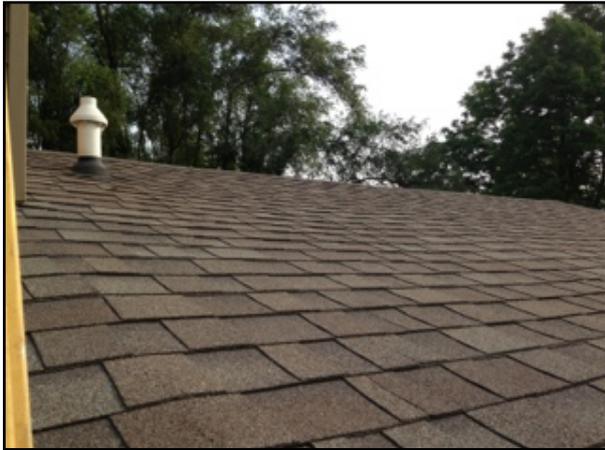
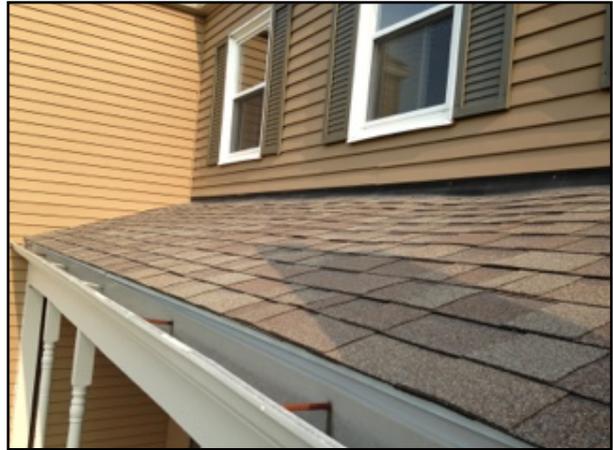
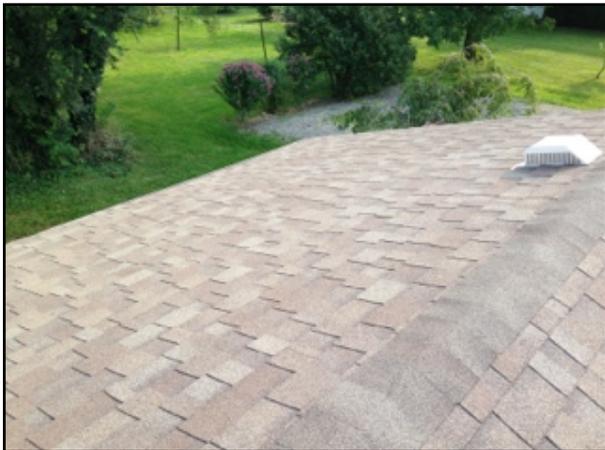
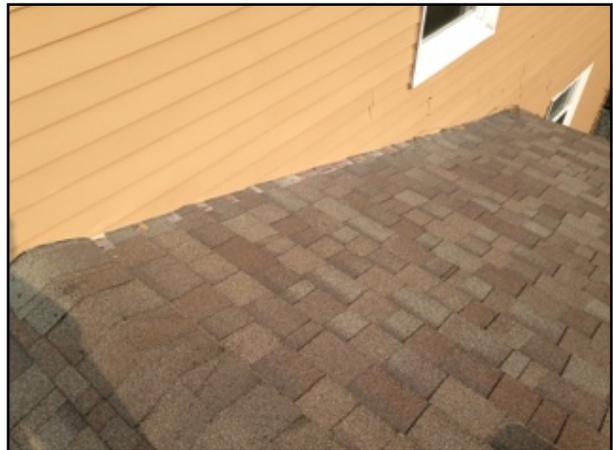
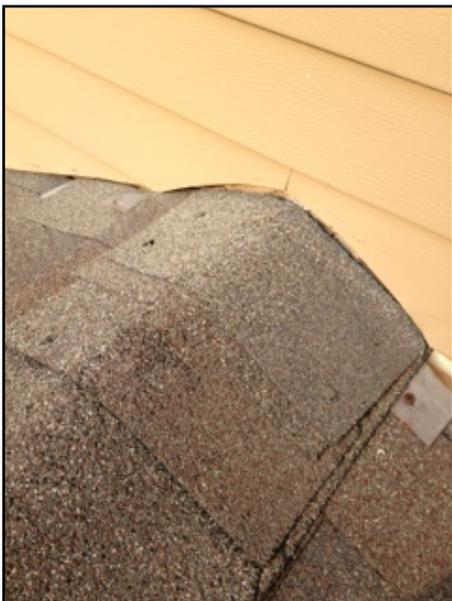
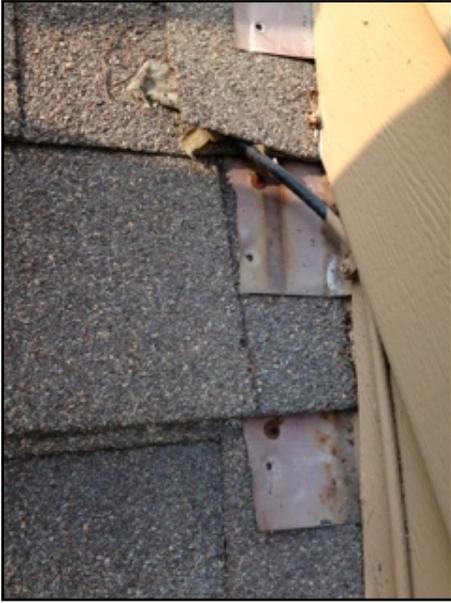
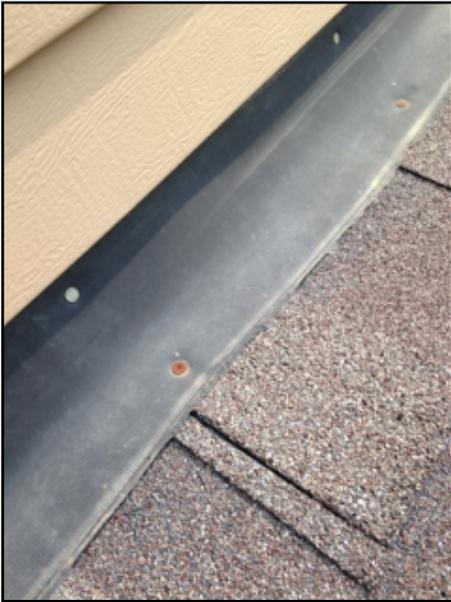
Front porch roof depression in roof sheathing possible prior water damage hidden.

Head flashing where shingles meet wall of home rubber perimeter roof material instead of metal

Lower front porch roof left side no visible step flashing or diverter flashing at wall.

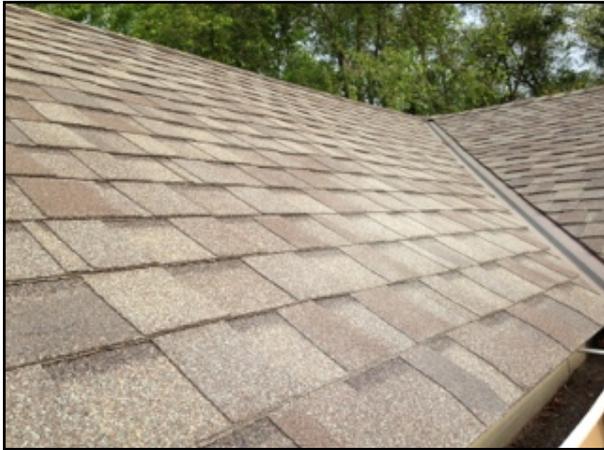
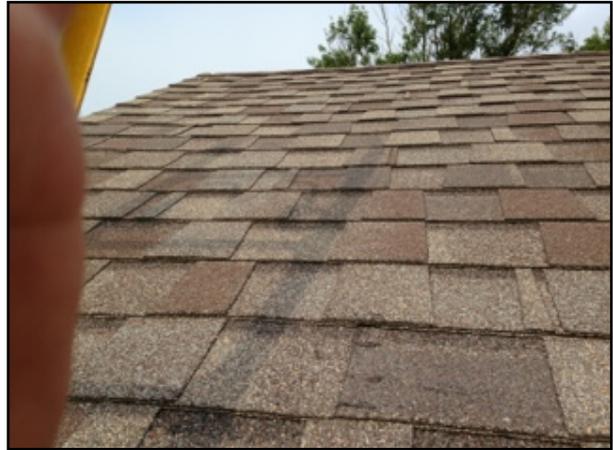
Comment 18:  
Roof Photos upper main roof.

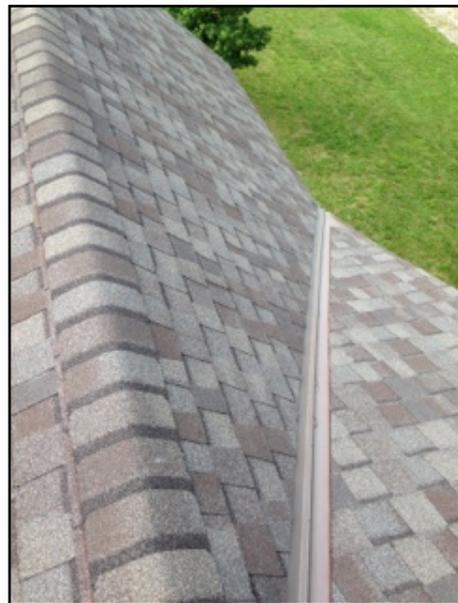
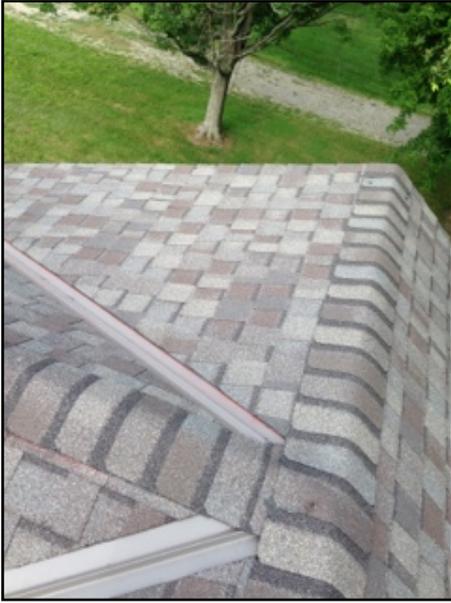
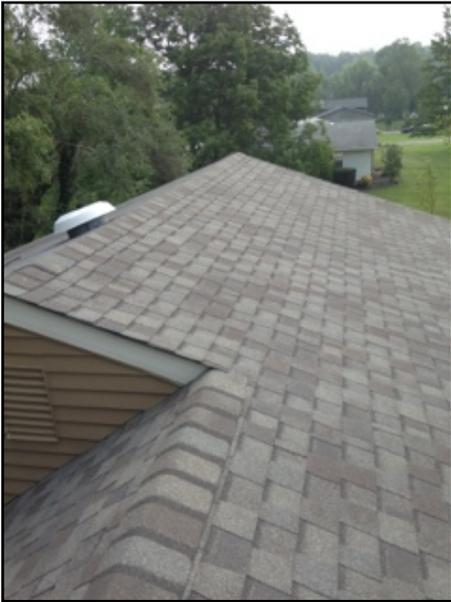
Comment 19:  
Upper main roof rear side not replaced.  
Shingles are older and three tab gray not dimensional.  
Rear section shingles not replaced double layer at this time.

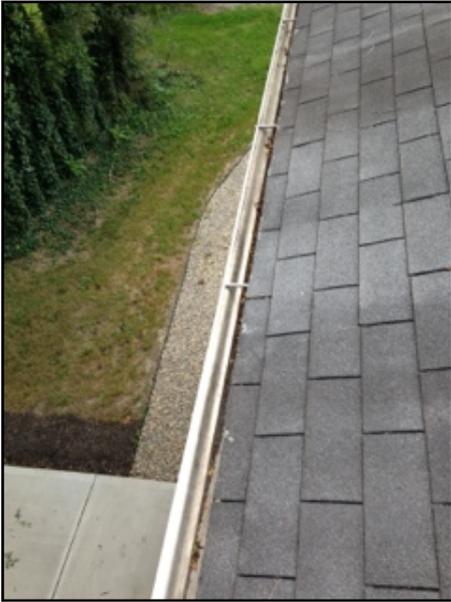
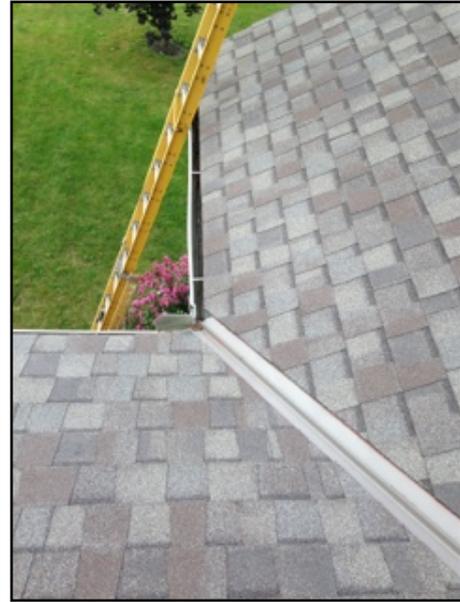
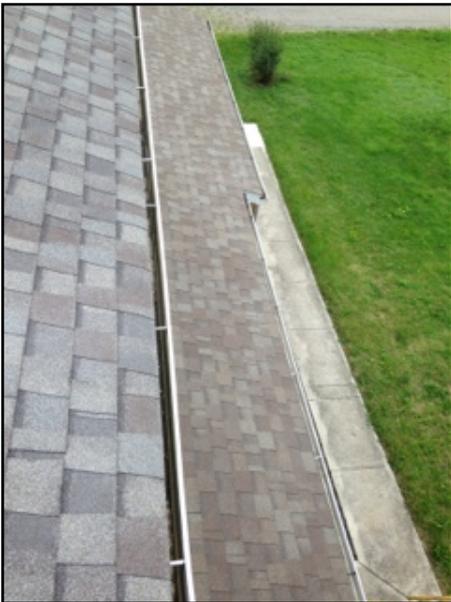
Comment 20:  
Gutters clogged upper main roof and lower.

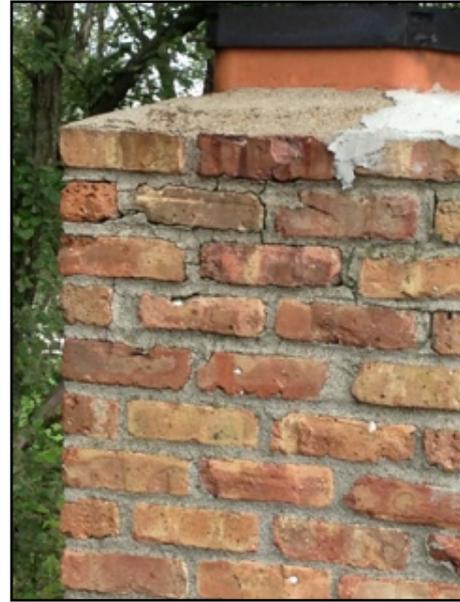
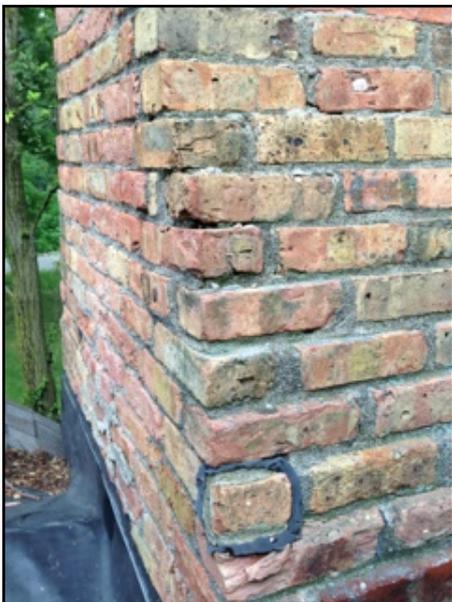
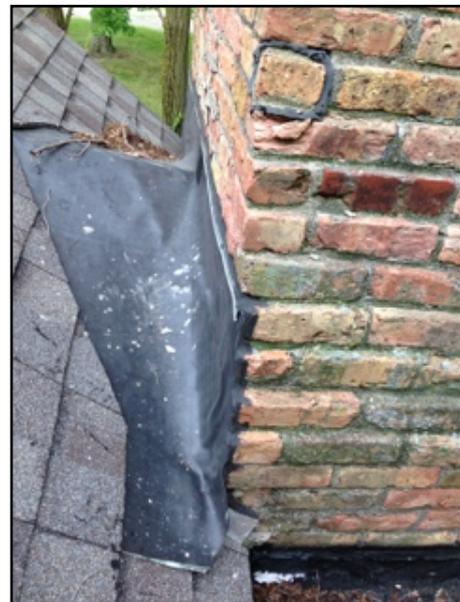
**Comment 21:**  
Chimney in need of repairs tuckpointing at brick mortar joints and top Cap repairs.  
Cricket is covered with rubber roof material.

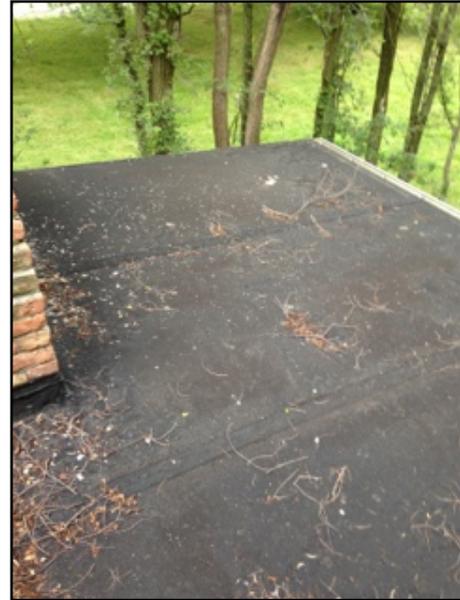
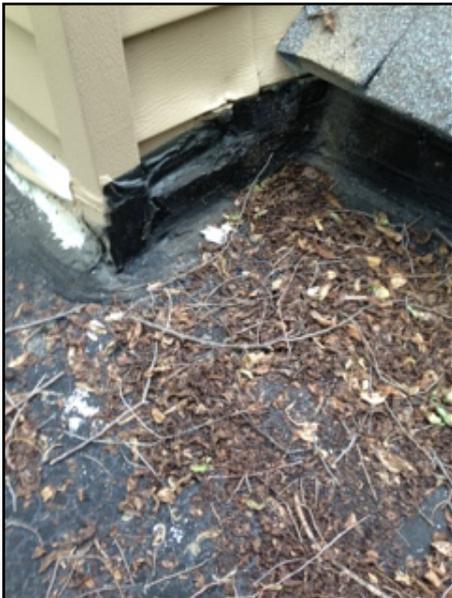
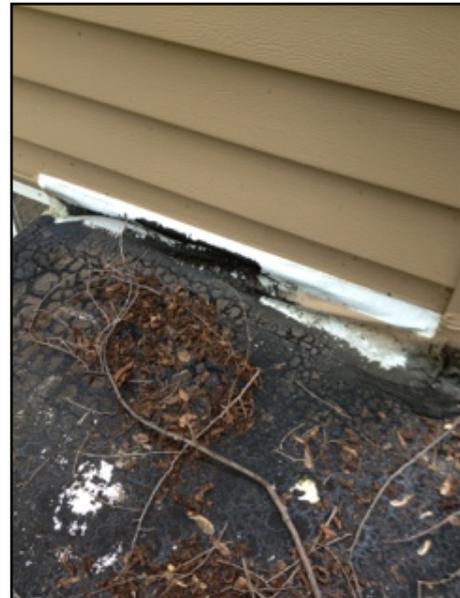
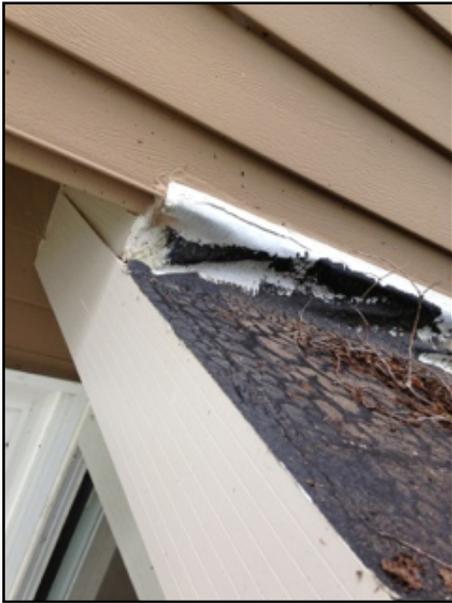
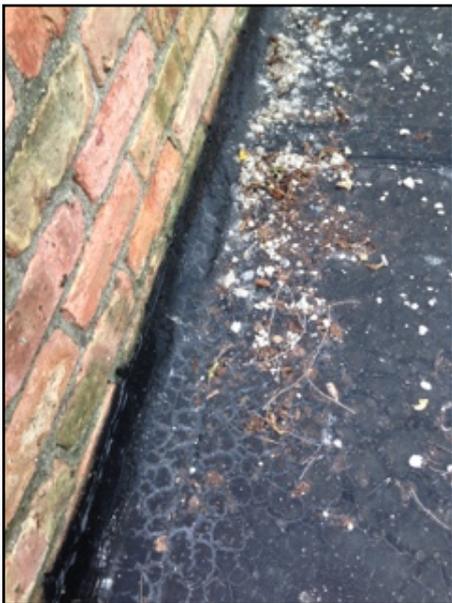
Rubber roof patch material used for flashing between home and flat roof is now in deteriorated state.

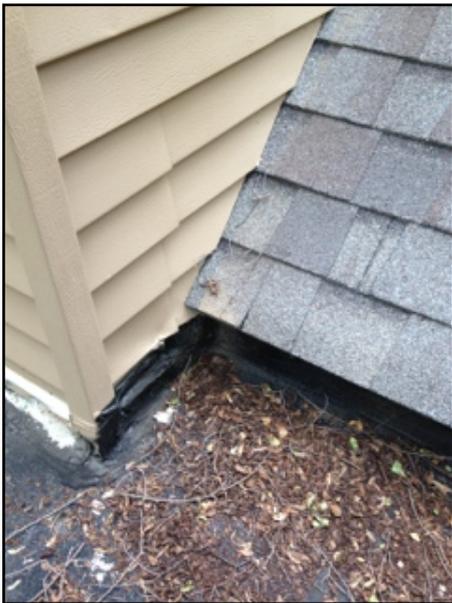
Figure 23-1

**Comment 23:**  
Rear side left roof no diverter flashing.

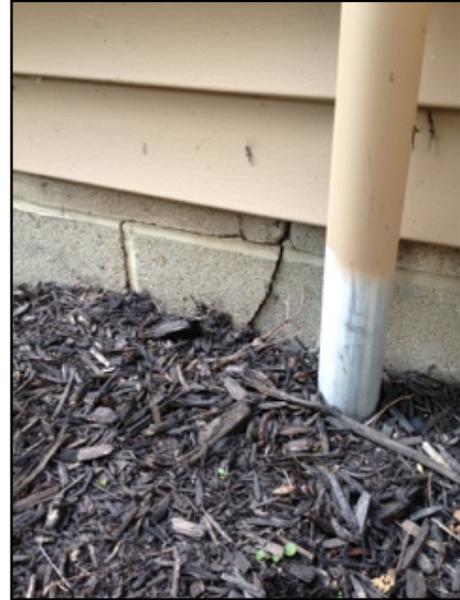
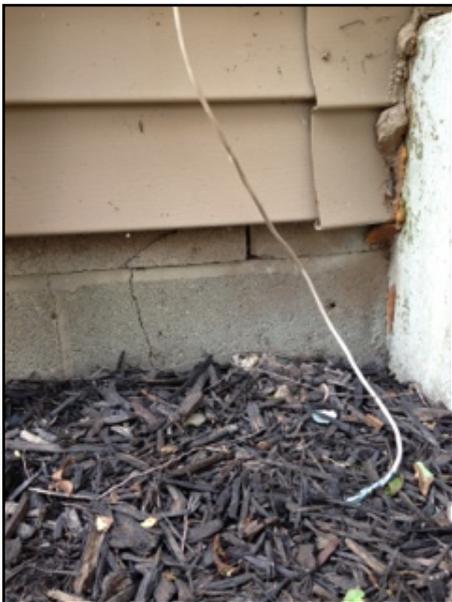
Concrete block cracks foundation wall rear side garage where meets home and concrete steps.

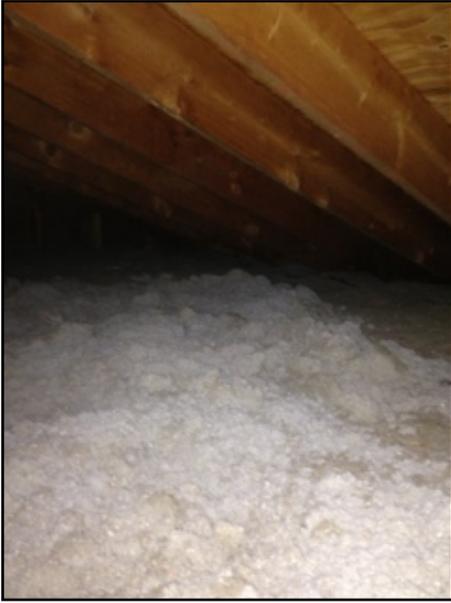
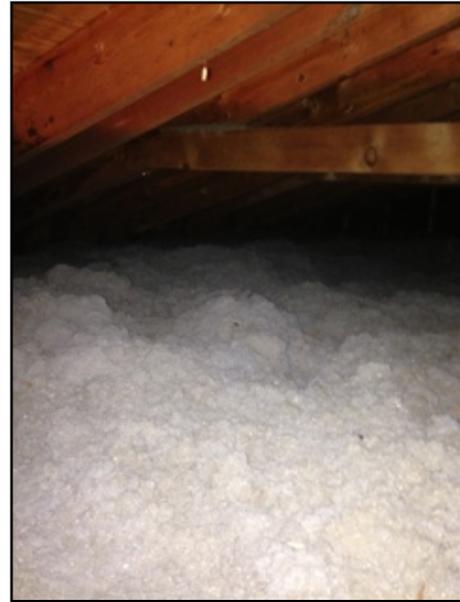
Mold like staining visible at the lower perimeter of the attic.

The staining appears to be caused by lack of soffit venting.

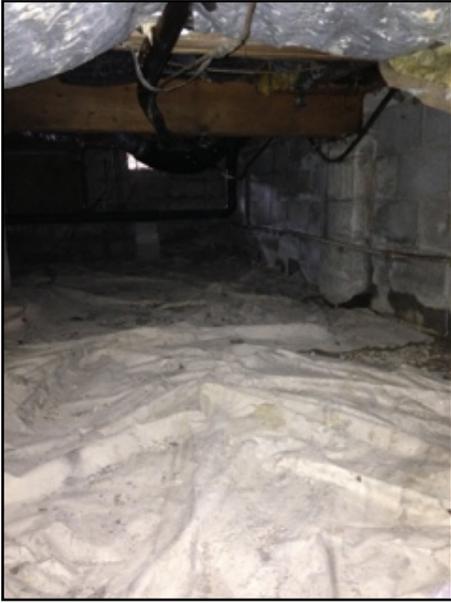
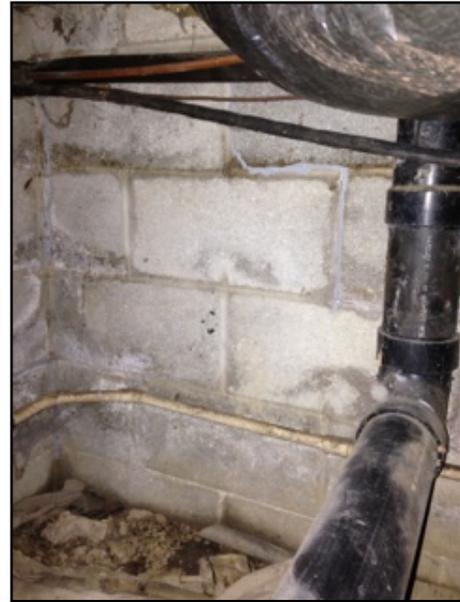
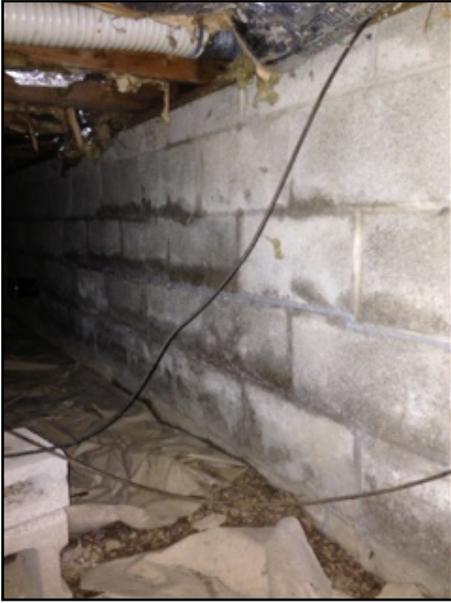
Rear wall of crawl has multiple cracks filled with caulking. Appears wall pushed inward. Further evaluation recommended.

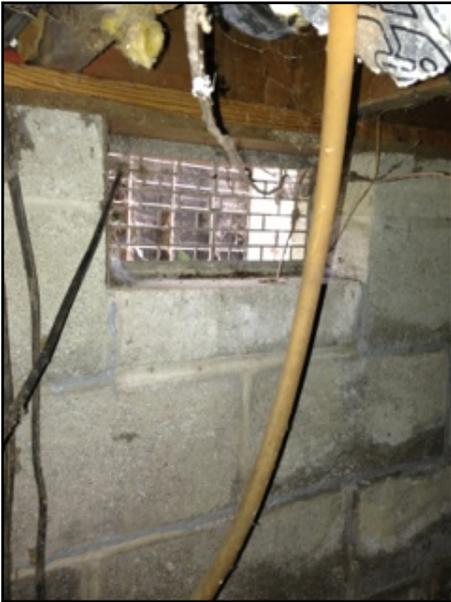
Figure 28-1

Comment 28:  
Crawl space vents not screened over.

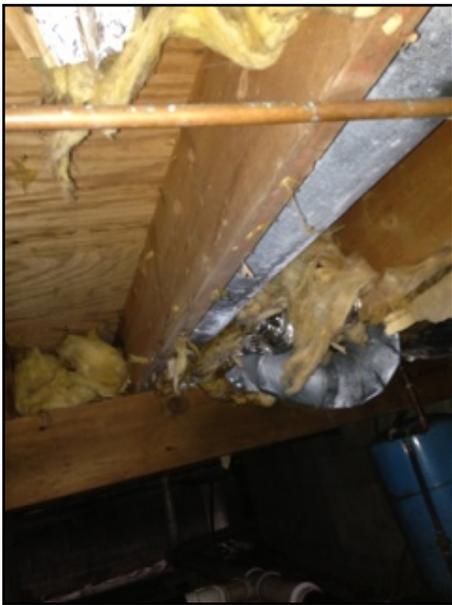
Under floor insulation damaged in need of repair.

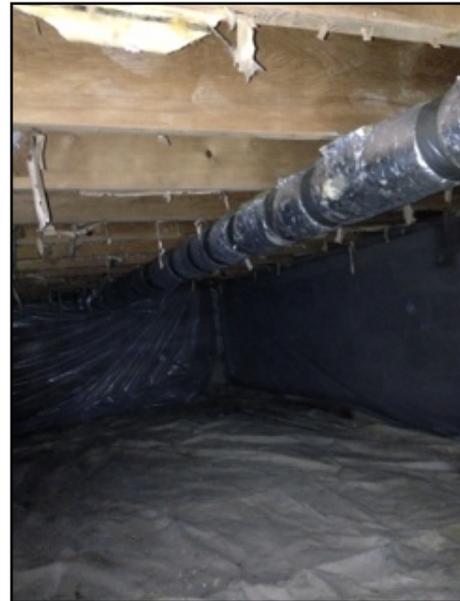
Figure 31-2

Insulation majority has been removed and not replaced.  
Insulating under the floors of home in need.

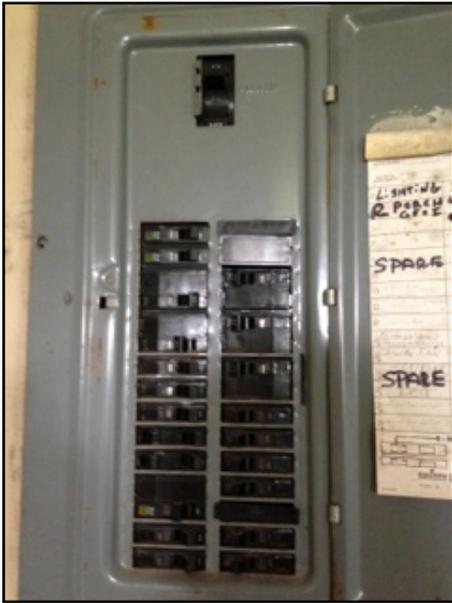
**Comment 32:**  
Exterior meter box and interior panel.  
Visible rust at breaker faces.

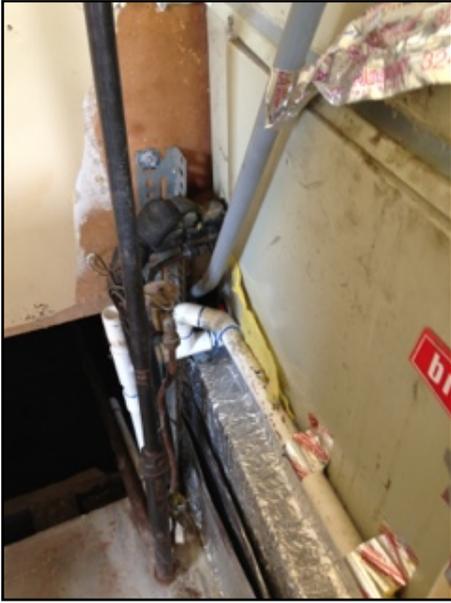
Possible condensate leaks at rubber drain tubing in furnace.  
Recommended servicing unit for efficiency and cleaning.

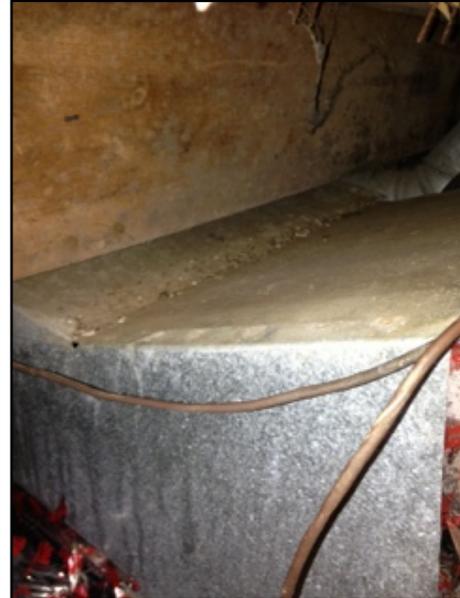
Figure 37-2

Duct and plenum not insulated. All seams of ducts leaking air into crawl below. Rodent feces visible in crawl.

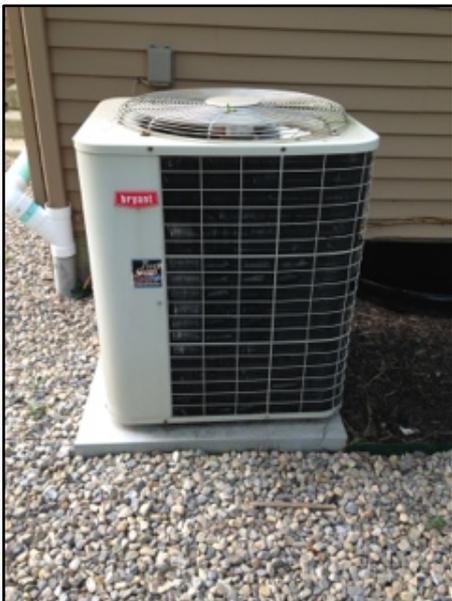
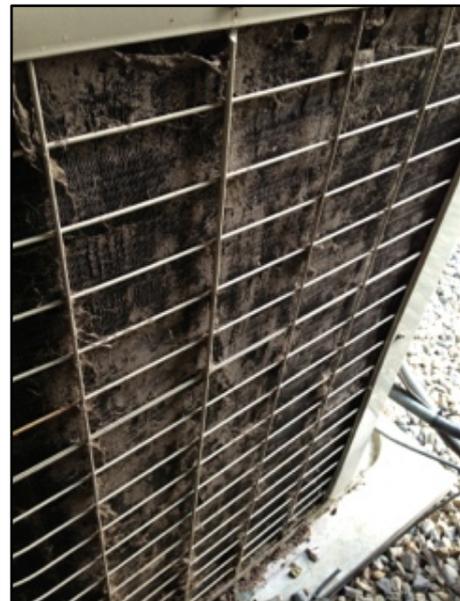
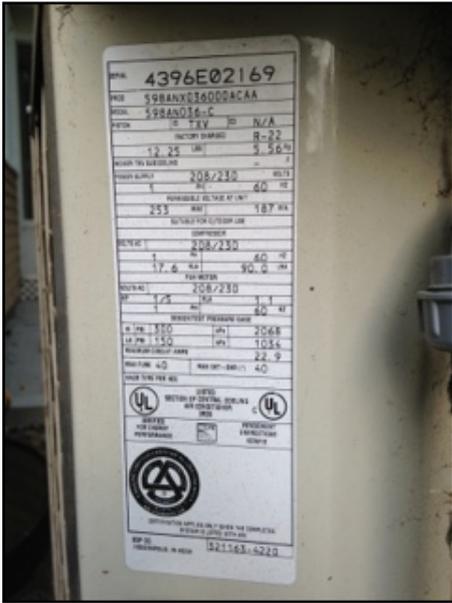
No freon line insulation at return freon line to unit.

Exterior cooling fins in need of cleaning.

Air conditioners over 10 years old and heat pumps over 5 years old should be checked, cleaned and serviced yearly by a licensed contractor.

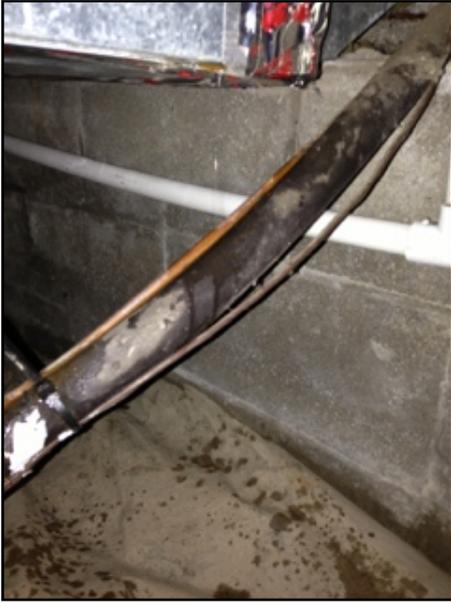
**Comment 39:**  
Condensate from duct. Possible clog at evaporator coil condensate tray.  
Servicing of unit is needed.

Condensate pipe is fastened to interior foundation block wall. Pipe has incorrect slope with sags in pipe. Will slow water flow with higher chance of clog.

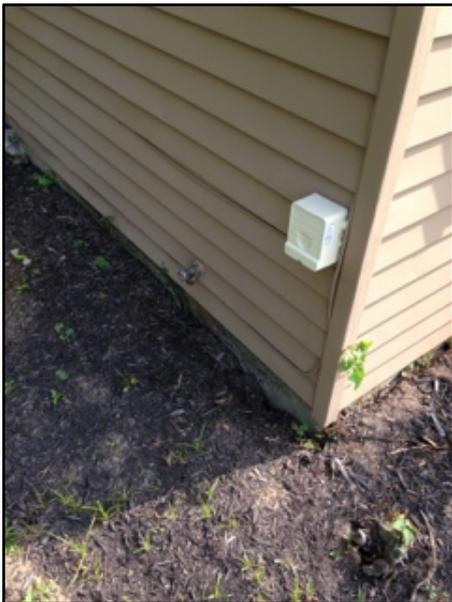
Figure 41-1

**Comment 41:**  
Exterior west spigot not operable at time of inspection .

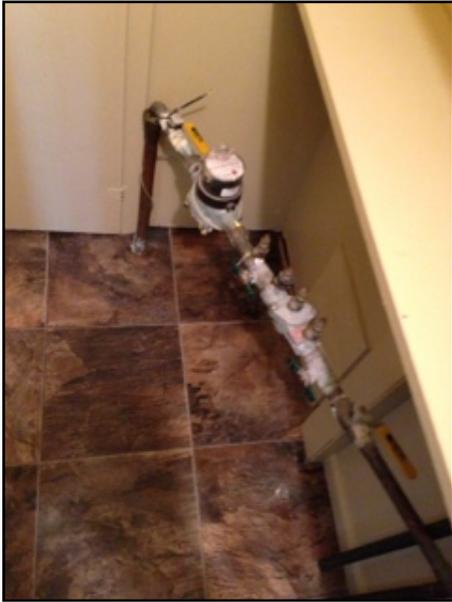
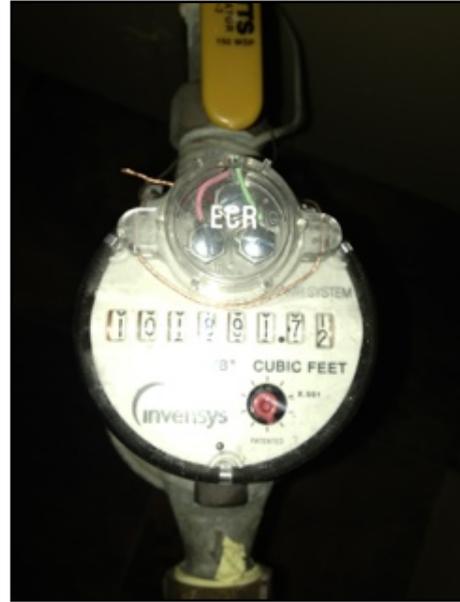
Comment 42:  
Water meter located in water heater closet.

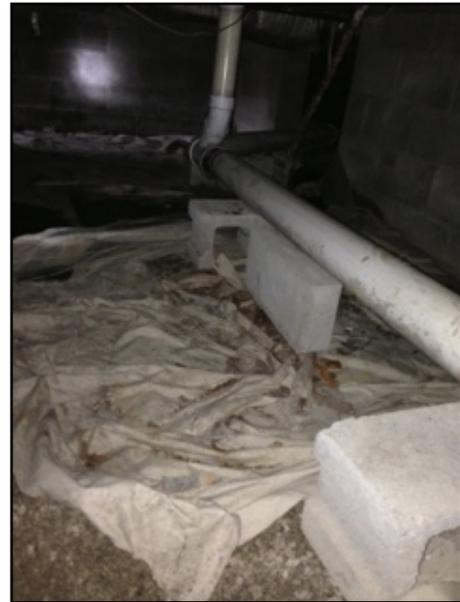
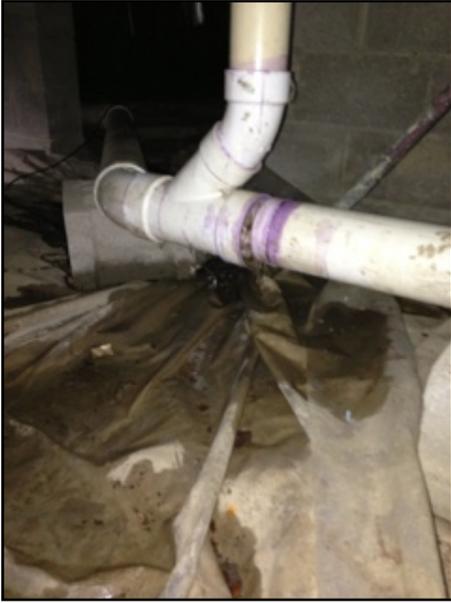
The crawl space in need of total cleaning and sanitizing prior to replacement with new vapor barrier due to sewage leaking throughout.

This is considered a major health hazard at this time.

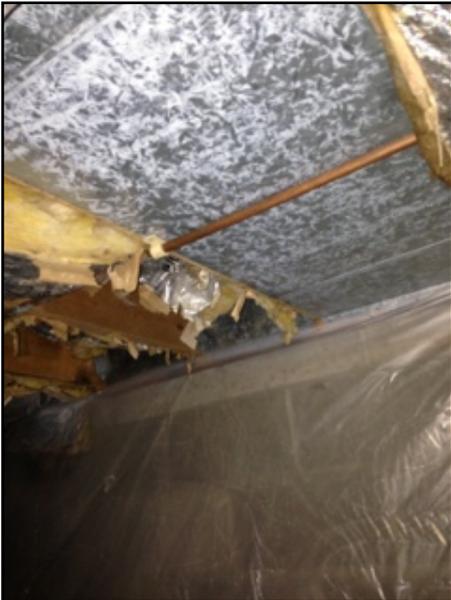
Figure 44-1

Water pipes copper and cpvc not insulated open to cold crawl.

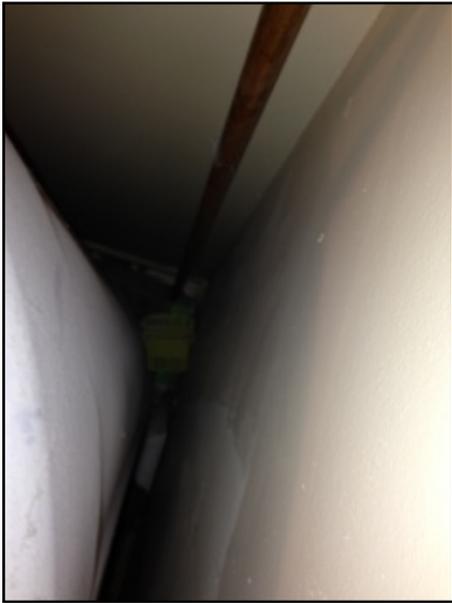
Elements appear to have been replaced prior years.

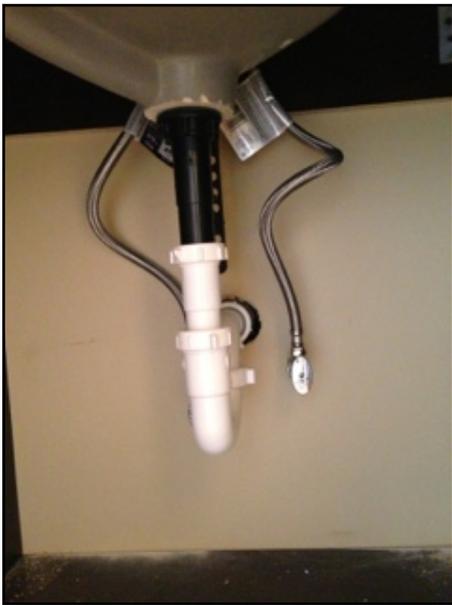
Comment 46:  
Bathroom photos.  
Toilet loose at floor.

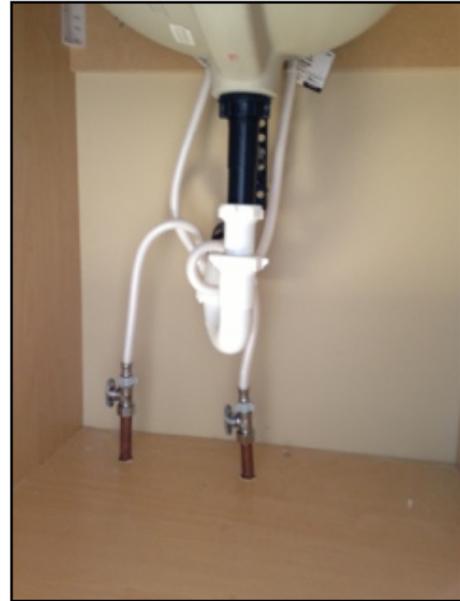
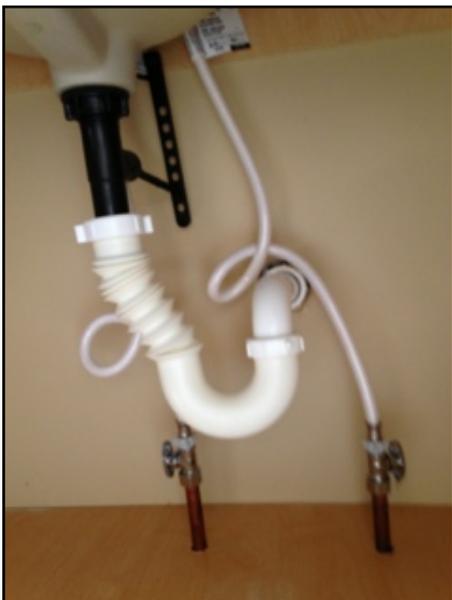
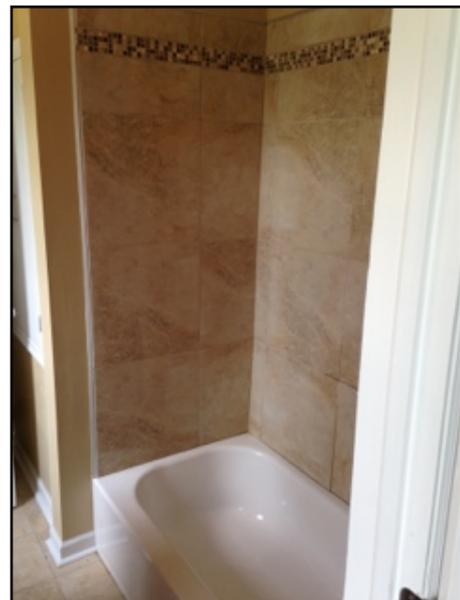
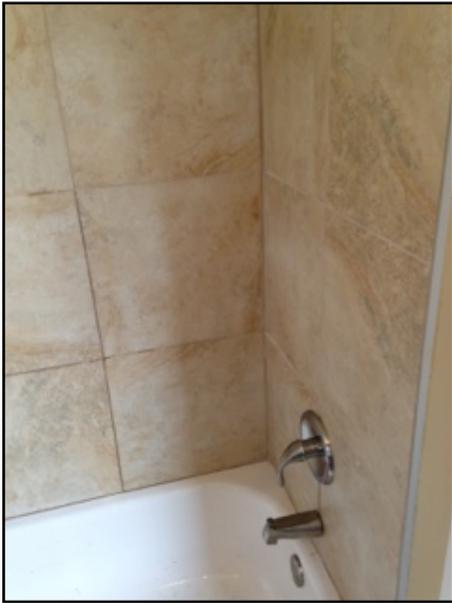
The bath spigot when guest turned on blew out black dirt/ rust in pipe. Possible iron pipe fitting between the feed copper pipe and spigot. Recommend further evaluation.
