## Home Inspection Report

**1234 Anywhere Rd.**

**Citywide, STATE 43000**

Inspected on Tue, Jul 30 2013 at 10:00 AM

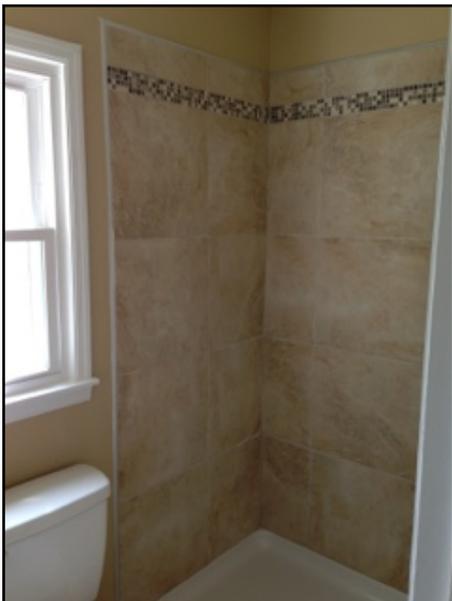
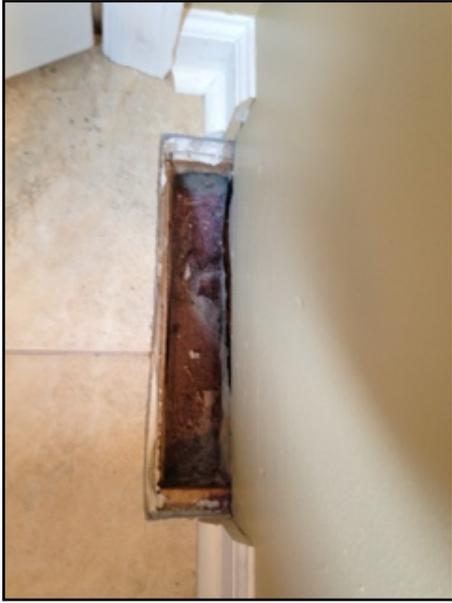
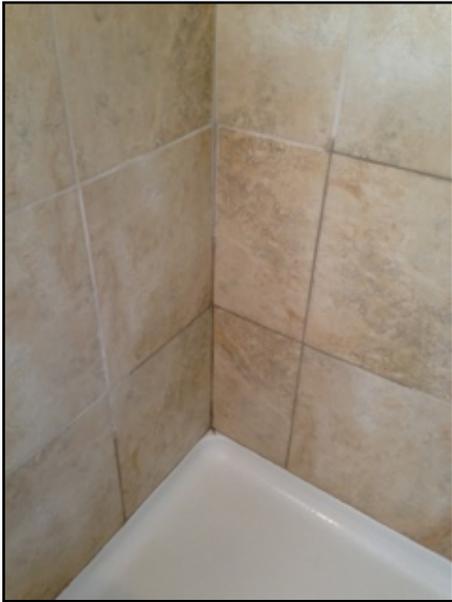
Grout joints cracked at inside corner in shower. Recommend monitor and seal with caulk.

Recommend seal around cover plate of faucet.

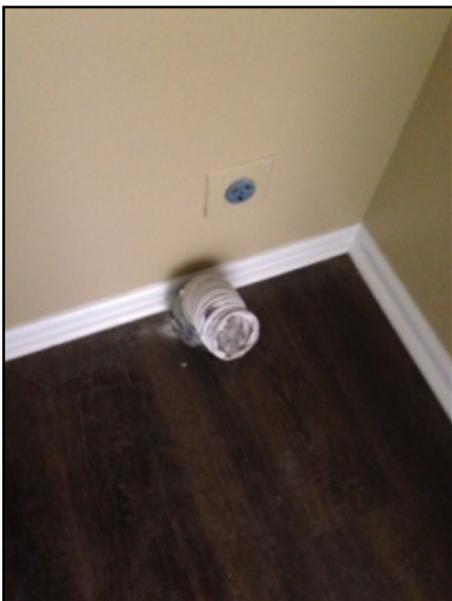
No seal where drain pipe comes through plastic insert for plumbing mounts.

Clean dryer vent pipe prior to use.

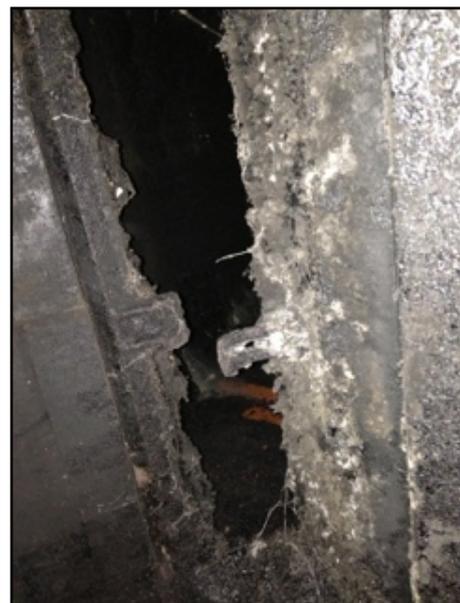
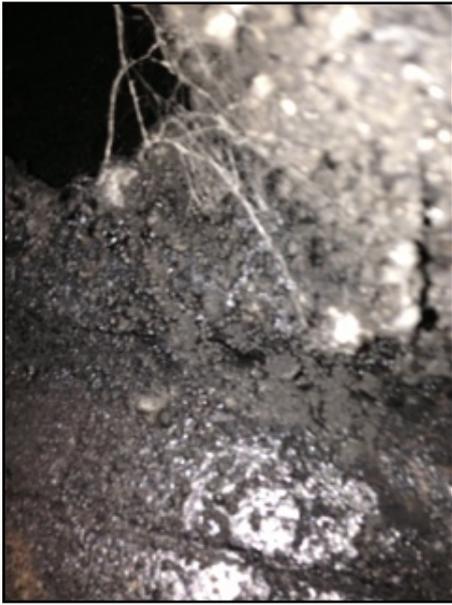
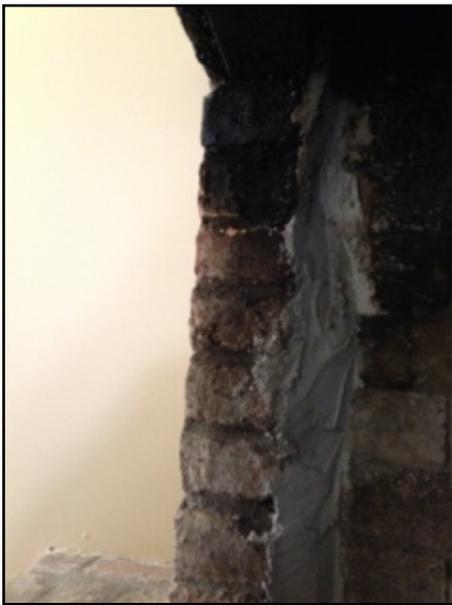
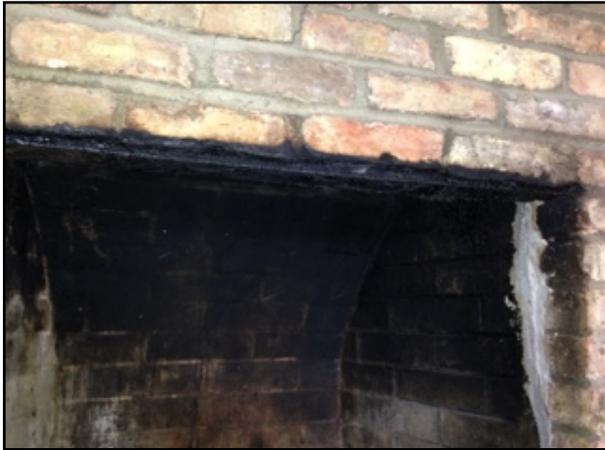
- Fireplace wood burning.
- No screen or doors.
- Damper plate missing.
- Heavy creosote buildup in flue.

Mortar between firebox and front face brick over prior creosote buildup. May need removed and then repairs made prior to new mortar being installed.

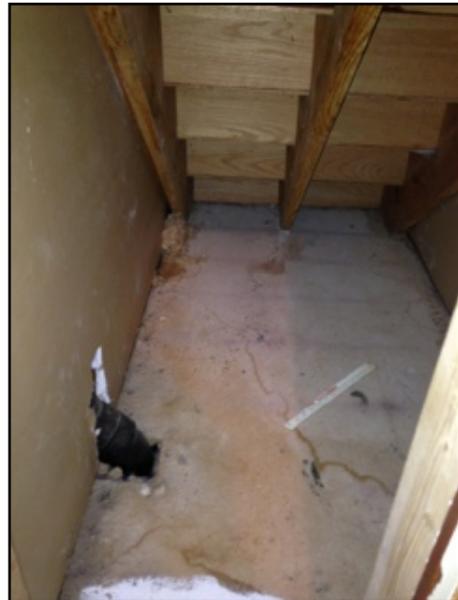
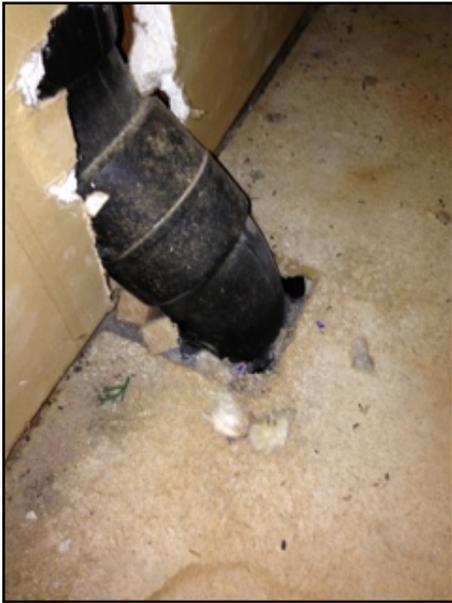
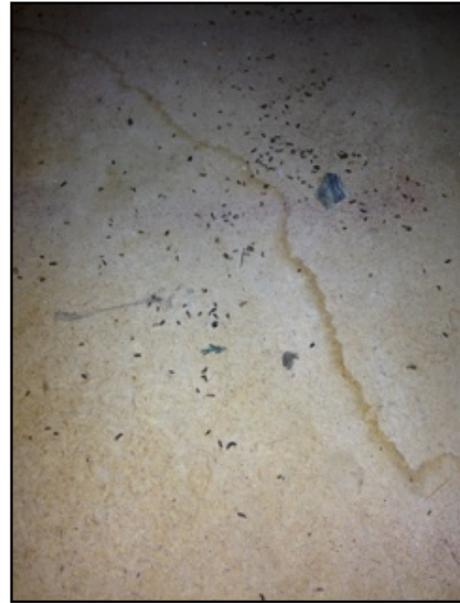
Storage area under the steps to upper floor accessible in water heater closet.  
Rodent feces throughout.  
Hole to crawl and hole in wall to upper floor.  
Smell of feces and urine in need of repairs and sanitizing.

Considered a health hazard at this time.

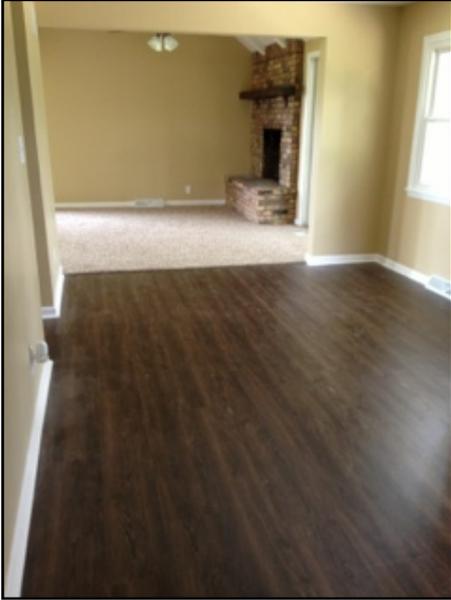
Figure 58-1

**Comment 58:**  
Interior floors slope downward from center. Possible settling of structure.
